# Annex E: Bat Survey Report (Part 1 - Main SRFI Site)

Rail Central

Project No. 855950

**Project No.:** 855950 Title: Rail Central Bat Survey Report (Main SRFI site) Client: Ashfield Land Management and Gazeley GLP Northampton s.à.r.l Date: 8 February 2018 Office: Coventry Status: Final **Technical Author David Cove** reviewer Corin Simmonds and love. Signature Signature Date: 8 February 2018 Date: 8 February 2018 Quality **Project Manager** reviewer Tom Coyne Roberta Epps lan lagre. Signature Signature 8 February 2018 Date: Date: 8 February 2018

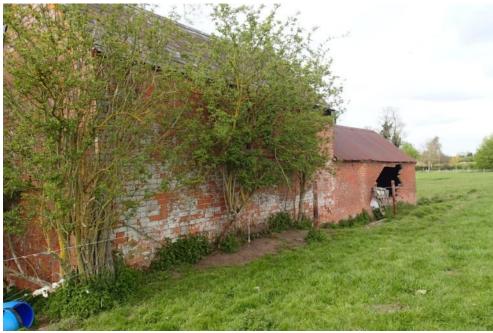
**Notes and Observations**: A field barn constructed of brick and is two storeys in height. The building has a pitched roof covered with slate tiles. The roof is in a generally poor condition with a large area of missing tiles on the west side allowing ingress of the weather. There are holes in the walls and there are missing windows and doors that allow flight access into the interior of the building. There are wooden barge boards on the gables allowing potential access beneath and onto the walls plates of the building. This building has extensive opportunities for roosting bats including large maternity colonies. No evidence of bats was found during the internal inspection. See *Photo Plates 1 - 9*, *Appendix B.*

Plate 2 - BG1 -Barns 1 and 2 external view showing hole into building through wall.

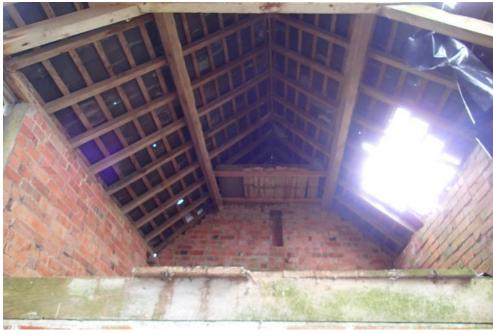
Plate 4 - BG1 -Barn 1 - Internal view of roof also showing barn owl nesting area.

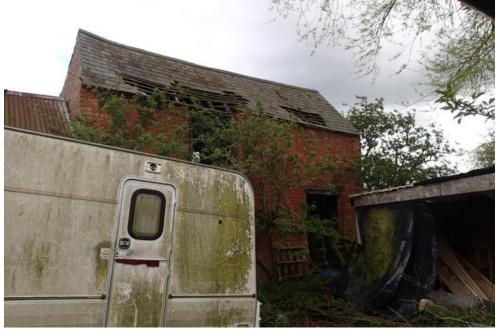
Plate 6 - BG1 -Barn 1 - External View of Roof showing damage

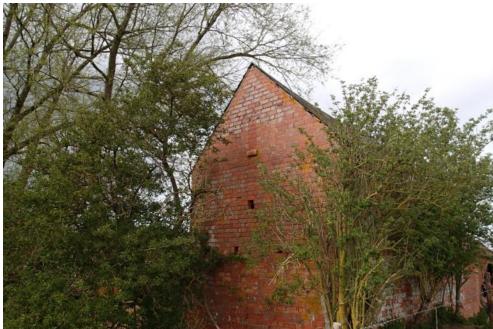
Plate 7 - BG1 -Barn 1 - Gable end showing cavities

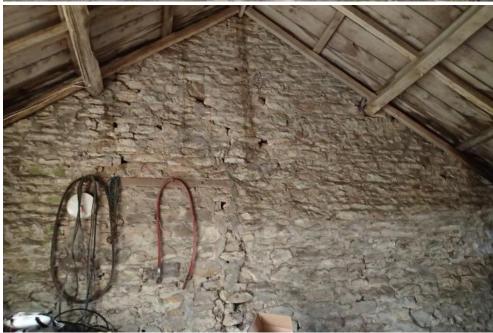
1) The barn is an extension of B2-Building 1 above. It lies on an East/West axis. The barn is constructed from a combination of brick and stone with a pitched slated roof with a gable end at its east end. The upper part of the gable is exposed but it is well pointed with no potential access. The lower section of the east wall has numerous areas of missing mortar leading to internal cavities offering potential roosting. Within the south elevation there are double cart doors with the doors remaining open during the spring and summer months. The interior of the barn is open to the roof throughout with exposed wooden sarking beneath the roof slates. There is a mezzanine level at the east end of the barn. The internal walls have gaps within the mortar leading to cavities within the walls providing potential roosting opportunities. There is also a gap at the top of the west wall internally that leads into the roof void of B2-Building 1. The barn is used generally as a workshop and for storage of smaller pieces of farm machinery so is a relatively disturbed area. Two very old bat droppings were adhering to an internal wall of the

Plate 14 - BG2 -Building 2 -Internal View of barn wall showing extensive crevices.

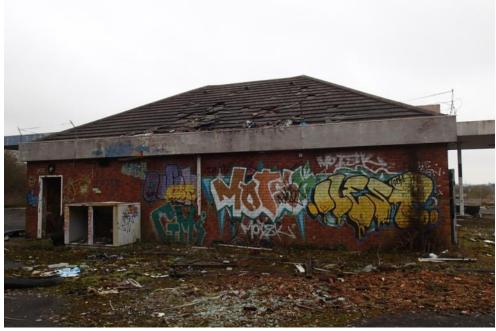
**Notes and Observations:** This building is a service station that is accessed off of the A43. It consists of access roads, hard standing, and a covered canopy area with petrol pumps and a retail shop. The structures are derelict and have been subject of vandalism. The canopy is constructed of metal panels with a flat metal roof with no potential access to any voids. The retail shop is constructed around a steel frame with panel walls and windows and has a pitched roof. There has been damage to the front of the shop allowing the weather to penetrate the interior. There are no gaps or crevices suitable for bats within the interior. There are no potential access points to the interior of the small cavity within the roof. *Photo Plates 29 – 31, Appendix B.*

Plate 31 – Garage – View of rear of retail unit showing extensive damage to roof.

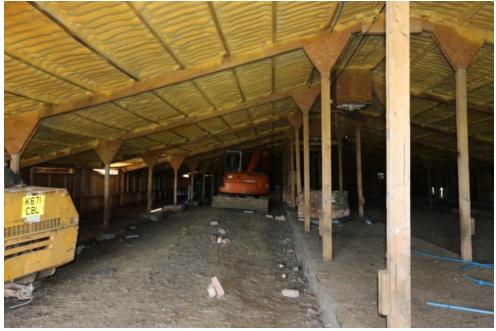
Plate 37 – BG10 Rathvilly Building 3 – Semi derelict Poultry shed – Internal view of shed showing insulation coating on underside of the roof

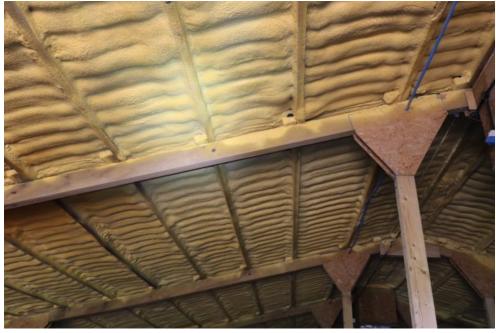
Notes and Observations: This building is a detached semi derelict former poultry shed. This is a large single storey building with a shallow pitched roof. The roof is constructed from corrugated panels and the undersides are coated with a spray on insulation material. The whole building is built around a steel frame. The walls are wooden panels with windows in all elevations. T windows are in considerable disrepair with many broken or open. At the east end of the building are large double doors that are permanently open. Internally the building is extremely dirty with large areas coated with a thick layer of dust. There are many crevices between the internal metal roof beams (that form part of the metal frame). The interior is used for the storage of farm machinery. A search of the building found a single dropping that was degraded but was Pipistrelle species in appearance.

Plate 38 – BG10 Rathvilly Building 3 – Semi derelict Poultry shed – close up view of interior showing gaps between metal frame and roof.
