### **RAIL CENTRAL**

## **APPENDIX 21.1 – SRFI Pre-Development Baseline Survey**

APPENDIX 21.1-DOC-1602403-20180301-Rail Central-DDM-IIP 001-P8 March 2018

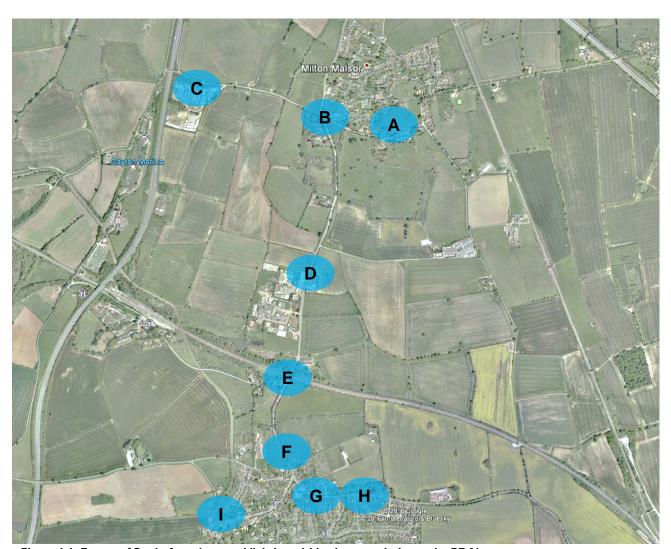
Sample locations are recorded within and adjacent to the PDA to provide an overview of the existing lighting conditions in order to ascertain the current Environmental Zone classifications.

Figure 1.1: Extent of Study Area (external lighting within close proximity to the PDA)

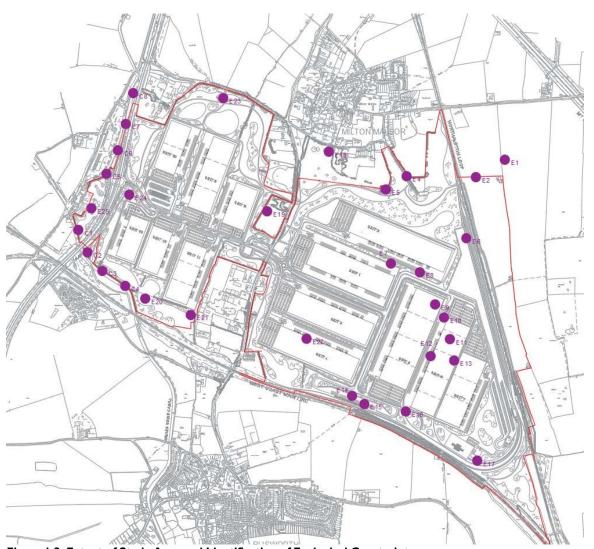
- E1 to E25: Ecology locations Potential Bat Roosts / Habitats, Foraging/Commuting routes
- CI to C4 Grand Union Canal
- C5 to C8 Northampton Aram

Figure 1.2: Extent of Study Area and Identification of Ecological Constraints

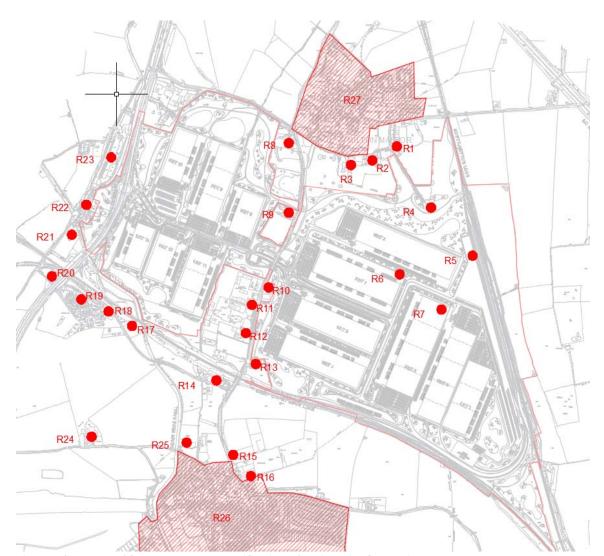
- RI: Properties on Barn Lane
- R2: Properties on Rectory Lane
- R3: Mortimers/The Old Rectory
- R4: Rathvilly Farm (\*)
- R5: Lodge Farm (\*)
- R6: Manor Farm (\*)

- R23: Gayton Marina
- R24: Hill Farm
- R25: Chapel Hill Farm
- R26: Village of Blisworth Representative zone of Residential Receptors
- R27: Village of Milton Malsor Representative zone of Residential Receptors

Figure 1.3: Extent of Study Area and Identification of Residential Constraints

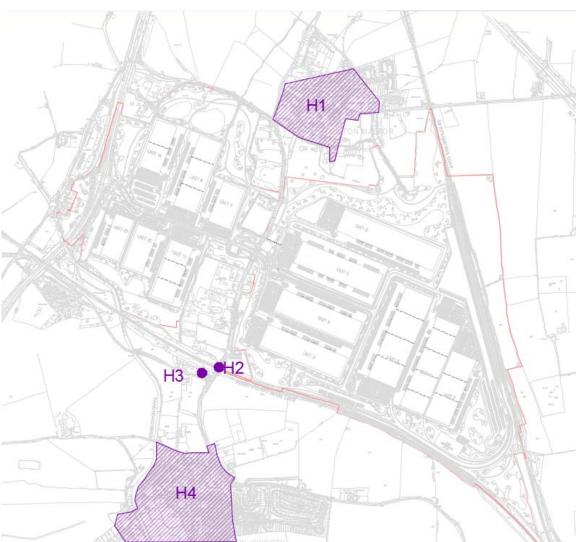
- HI: Milton Malsor Representative zone of Heritage receptors
- H2: Railway Bridge (Grade II listed)
- H3: Grafton Villas (Grade II listed)
- H4: Blisworth Representative zone of Heritage receptors

Figure 1.4: Extent of Study Area and Identification of Heritage Constraints

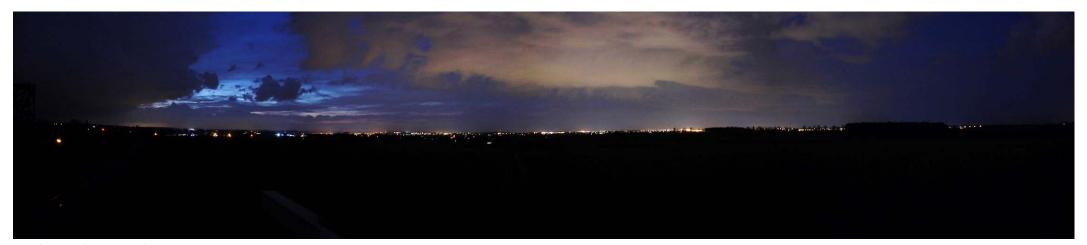
PDA - View from Milton Crossing Foot Bridge

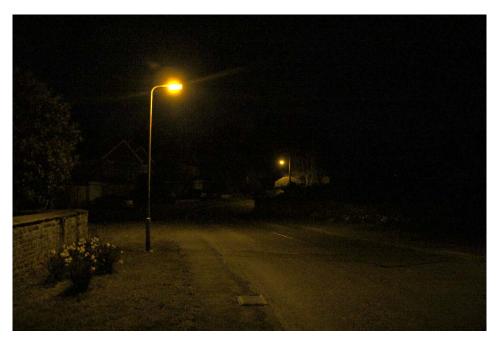
Existing Lighting A - Rectory Lane

Roadway is currently artificially lit with approximately 6m column mounted discharge lanterns to achieve an average light level of 6 Lux.

Average light levels equivalent to a S4 classification (BS 5489-1:2013)

Typical of an E2 Zone: Rural / Village Low district brightness

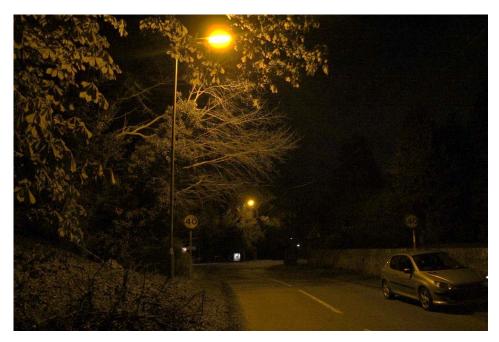
Existing Lighting B - Rectory Lane / Towcester Road

Roadway is currently artificially lit with approximately 8m column mounted discharge lanterns to achieve an average light level of  $9 \ Lux$ .

Average light levels equivalent to a S3 classification (BS 5489-1:2013)

Typical of an E2 Zone: Rural / Village Low district brightness

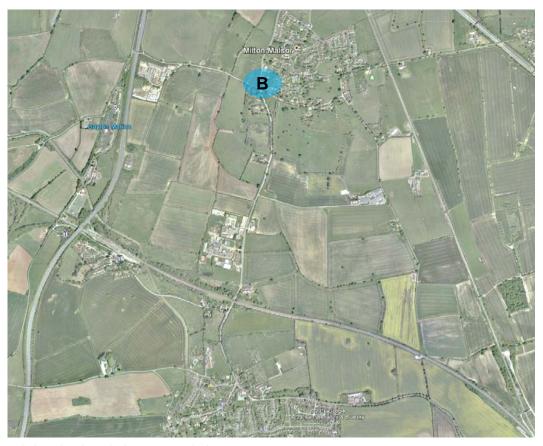
Grid reference: SP 73158 55463

Existing Lighting within close proximity to the PDA

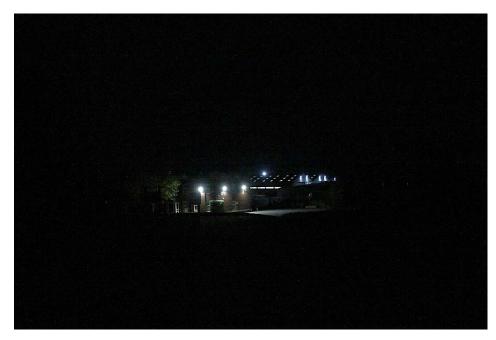
Existing Lighting C - Industrial / Commercial premises (Gayton Road)

Building mounted floodlight equipment to Industrial / Commercial premises.

Due to access limitations light level measurements were not taken, however based on professional judgement it can be assumed as being average horizontal light levels of 10 lux at ground level commensurate with parking areas / security lighting.

Typical of an E2 Zone: Rural / Village Low district brightness

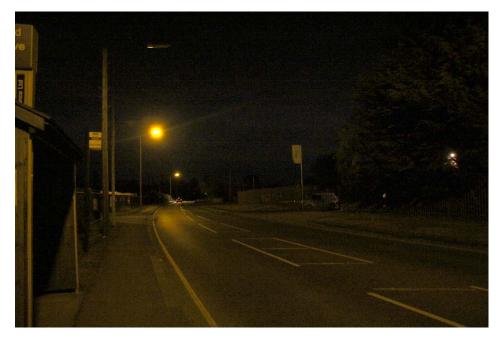
#### Existing Lighting D - Northampton Road

Roadway is currently artificially lit with approximately 10m column mounted discharge lanterns to achieve an average light level of 9 Lux. Floodlighting to adjacent commercial premises can be noted to contribute to the overall existing obtrusive light condition.

Average light levels equivalent to a S2 / S3 classification (BS 5489-1:2013)

Typical of an E2 Zone: Rural / Village Low district brightness

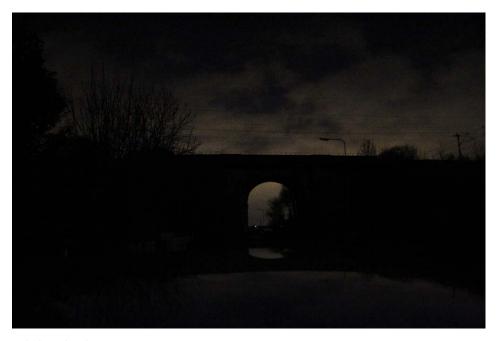
Existing Lighting E - Northampton Road

Lighting equipment was non-operational.

Partial sections of the highway were observed as being unlit at the time of survey and this is attributed to current engineering works being undertaken by the local lighting authority

However it is noted that lighting columns and luminaires present were comparable with those installed as measured at Location D.

Therefore it can be adjudged that whilst operational the average light level is likely to be of approximately 9 Lux.

Average light levels equivalent to a S2 / S3 classification (BS 5489-1:2013)

Typical of an E2 Zone: Rural / Village Low district brightness

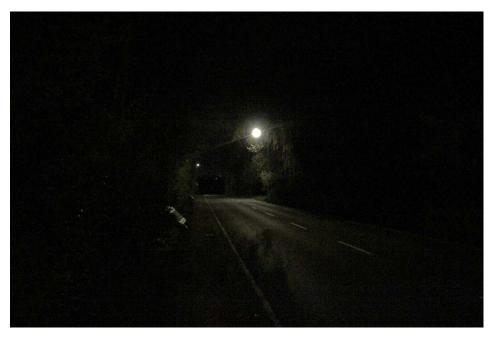
Existing Lighting F - Northampton Road

Roadway is currently artificially lit with approximately 8m column mounted discharge lanterns to achieve an average light level of  $6 \, \text{Lux}$ .

Average light levels equivalent to a S3 / S4 classification (BS 5489-1:2013)

Typical of an E2 Zone: Rural / Village Low district brightness

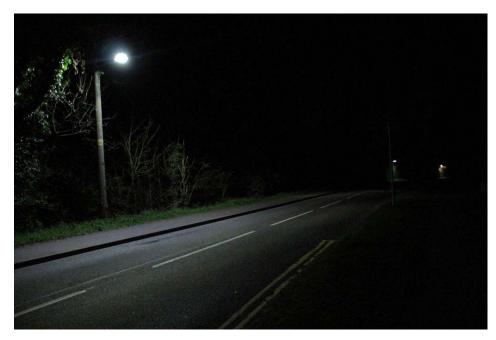
Existing Lighting G - Courteenhall Road / Windmill Avenue

Roadway is currently artificially lit with approximately 5m column mounted LED lanterns to achieve an average light level of 13 Lux.

Average light levels equivalent to a S1 / S2 classification (BS 5489-1:2013)

Typical of an E2 Zone: Rural / Village Low district brightness

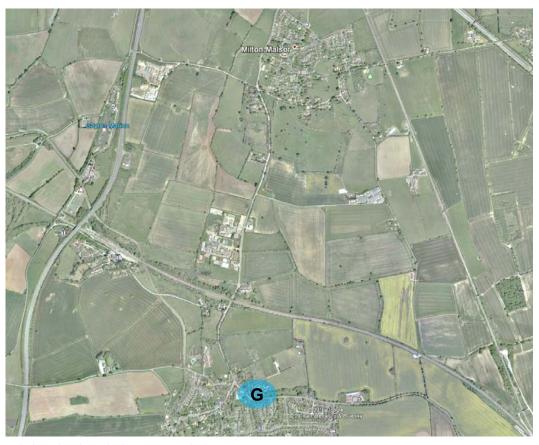
Grid reference: SP 73014 53524

Existing Lighting within close proximity to the PDA

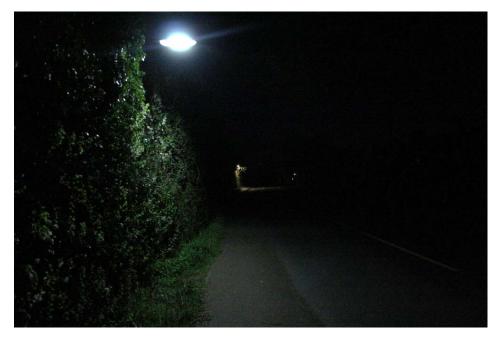
Existing Lighting H - Courteenhall Road / Connegar Leys

Roadway is currently artificially lit with approximately 5m column mounted compact fluorescent and discharge lanterns to achieve an average light level of 5 Lux.

Average light levels equivalent to a S4 / S5 classification (BS 5489-1:2013)

Typical of an E2 Zone: Rural / Village Low district brightness

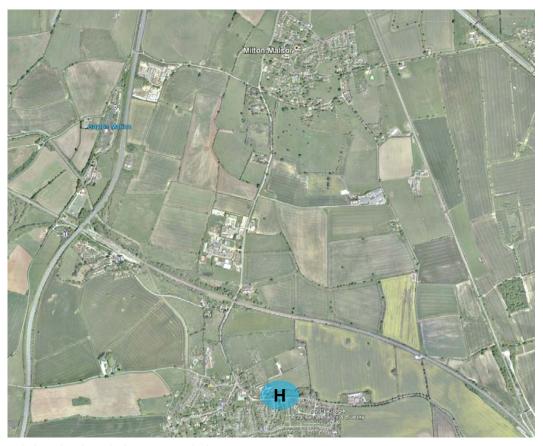
Grid reference: SP 73118 53523

Existing Lighting within close proximity to the PDA

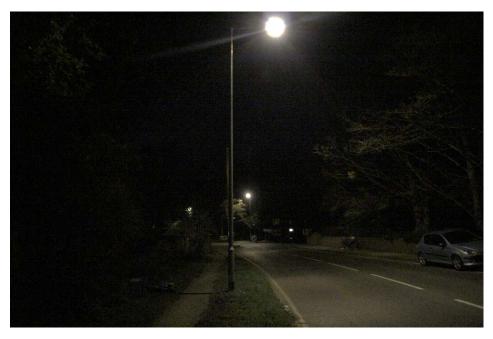
Existing Lighting I – High Street

Roadway is currently artificially lit with approximately 8m column mounted discharge lanterns to achieve an average light level of 6 Lux.

Average light levels equivalent to a S3 / S4 classification (BS 5489-1:2013)

Typical of an E2 Zone: Rural / Village Low district brightness

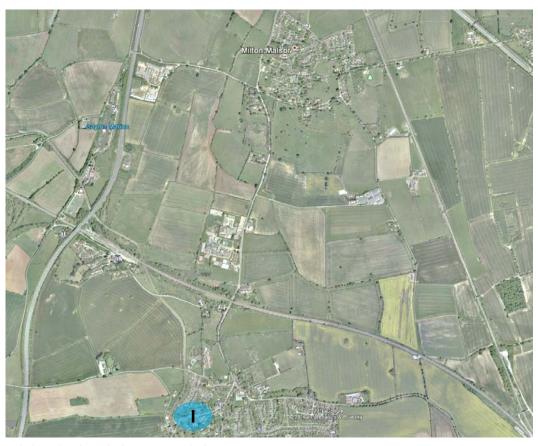
Grid reference: SP 72429 53419

Existing Lighting within close proximity to the PDA

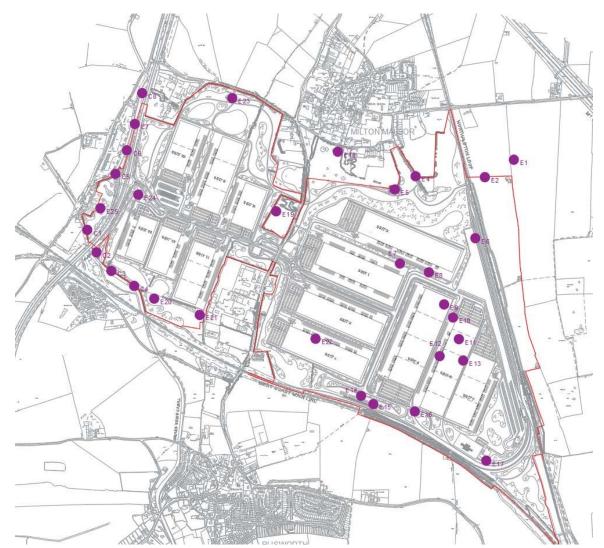
**Ecological Constraints**

Having a potential direct view of the PDA with changes in topography and minimal natural screening. Receptors judged to receive a baseline condition due to naturally occurring light levels only.

Measured peak horizontal illuminance @ Ground – 0.10 Lux (Moonlight condition) Measured peak vertical illuminance @ I.5m AFL – 0.13 Lux (Moonlight condition)

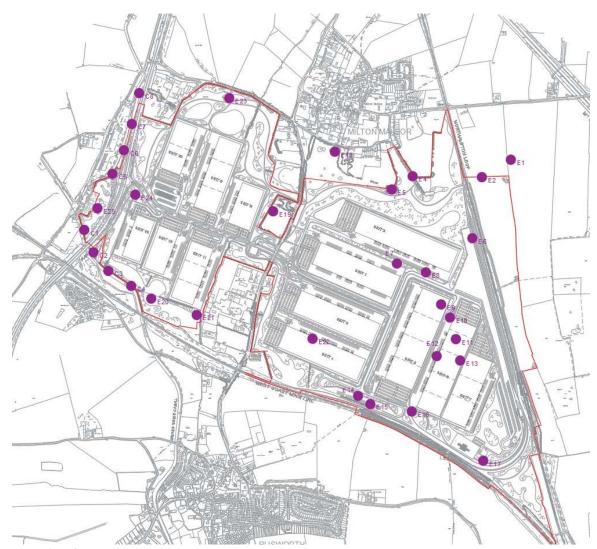
**Ecological Constraints**

Having a potential direct view of the PDA with changes in topography and minimal natural screening. Receptors judged to receive a baseline condition due to naturally occurring light levels only.

Measured peak horizontal illuminance @ Ground – 0.10 Lux (Moonlight condition) Measured peak vertical illuminance @ I.5m AFL – 0.13 Lux (Moonlight condition)

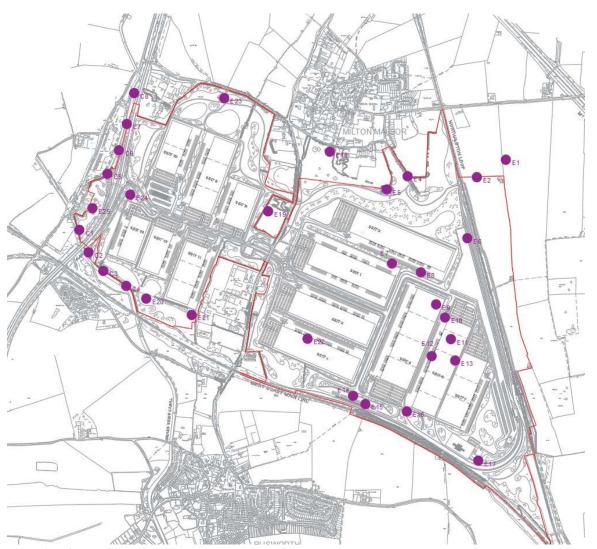
**Ecological Constraints**

Natural screening provided by existing tree lines and hedgerows, with changes in topography in relation to the PDA. This resulted in a reduction in measured moonlight condition.

Peak illuminance levels (C2) are likely to be a result of artificial lighting associated with Blisworth Marina.

Measured peak horizontal illuminance C2 @ Ground Level – 0.09 Lux Measured peak vertical illuminance C2 @ I.5m AFL - 0.79 Lux

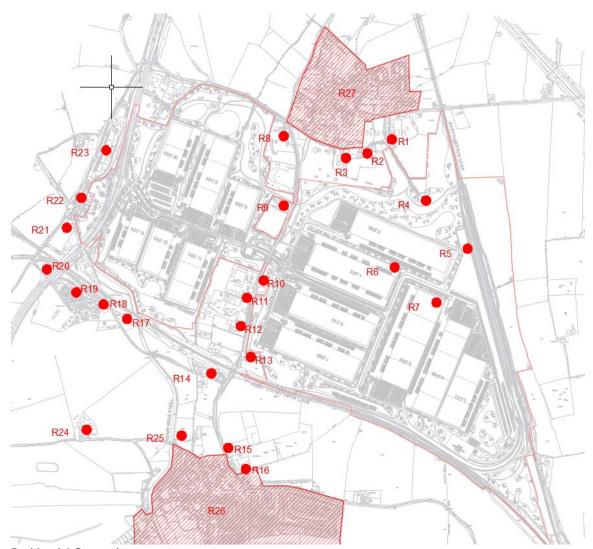
**Residential Constraints**

The majority of receptors with elevations having a potential direct view of the PDA are judged to receive a baseline condition due to naturally occurring light levels only. However this excludes R10 which was measured to receive a peak condition associated with existing highway lighting to Northampton/Towcester Road.

Measured peak vertical illuminance R10 @ 1.5m AFL – 2.72 Lux

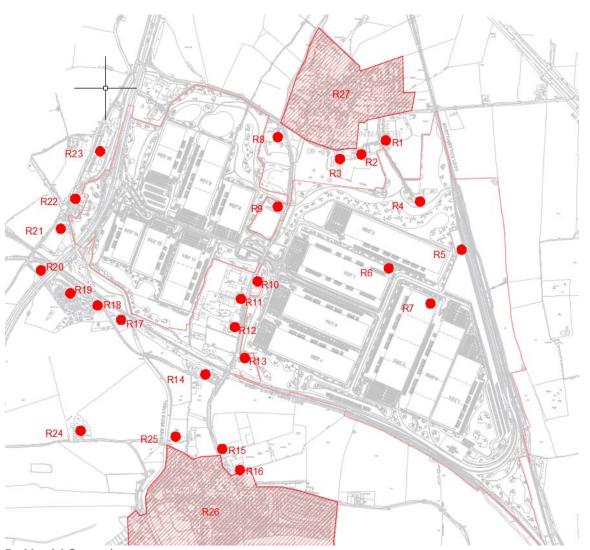
**Residential Constraints**

Natural screening provided by existing tree lines and hedgerows, with changes in topography in relation to the PDA therefore experiencing a limited direct view from elevations facing the PDA perimeter. Receptors are judged to receive a baseline condition due to naturally occurring light levels only.

Measured peak vertical illuminance R21-R23@ 1.5m AFL - 0.13 Lux (Moonlight Condition)

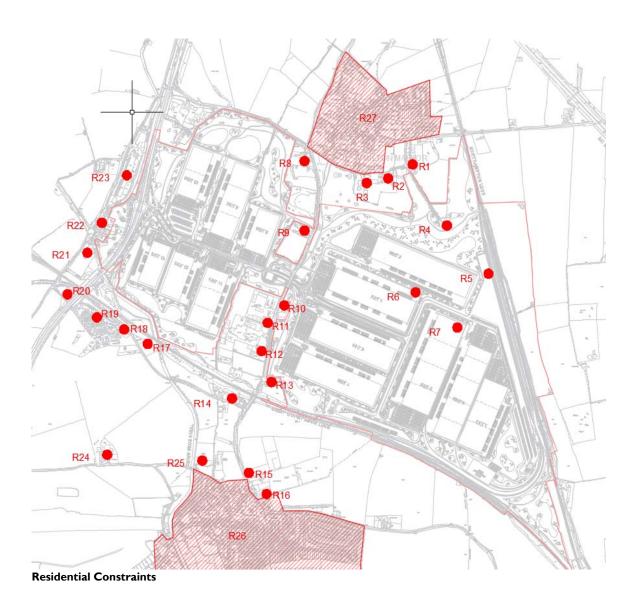
Natural screening provided by existing tree lines and hedgerows, with changes in topography in relation to the PDA resulting in a limited direct view to elevation facing the PDA perimeter. Representative zone is judged to receive a baseline condition due to naturally occurring light levels only.

Measured peak vertical illuminance R27 @ I.5m AFL – 0.13 Lux (Moonlight Condition)

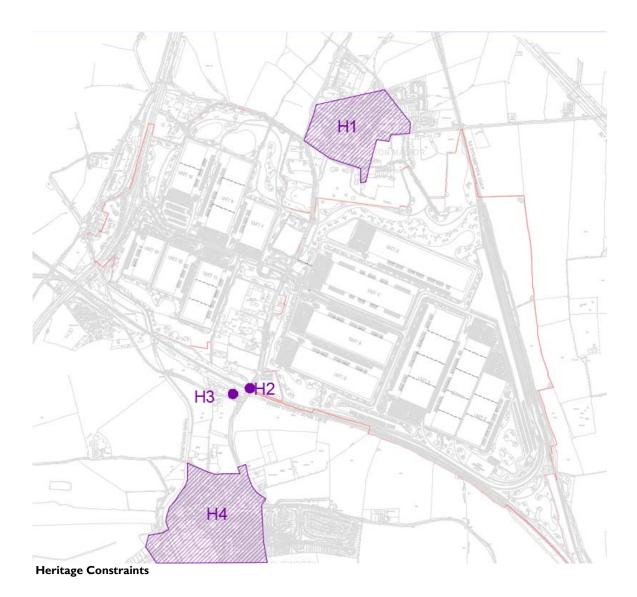
Natural screening provided by existing tree lines and hedgerows, with changes in topography in relation to the PDA resulting in a limited direct view to elevations facing the PDA perimeter. Receptors judged to receive a baseline condition due to naturally occurring light levels.

Measured peak vertical illuminance: H1 @ 1.5m AFL – 0.13 Lux (Moonlight condition)

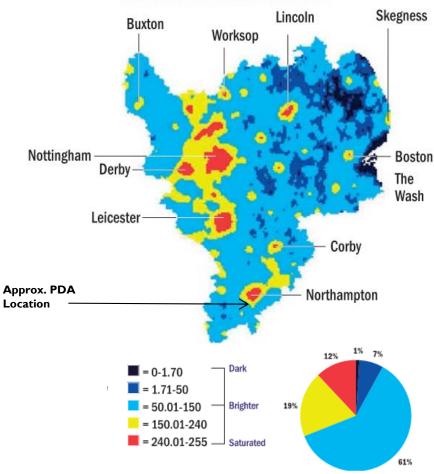
Figure 3.1: Night Sky Brightness (Sky Glow) within The East Midlands (2000)

Figure 3.1 adjacent, CPRE – Night Blight within the East Midlands gives a broad brush indication of the upwards light (sky glow) experienced for the year 2000 for the PDA location and further afield locations.

Satellite measurements range from 0 (being a dark sky) to 255 (being a saturated bright sky at night – city centre).

Taken on a local scale existing saturated sky glow is notable from major urban development of Northampton and associated conurbation.

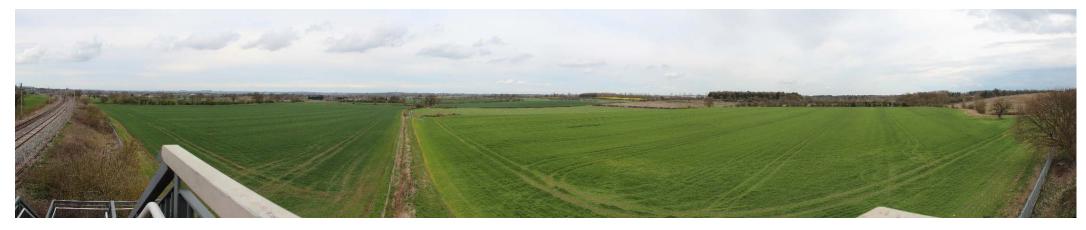
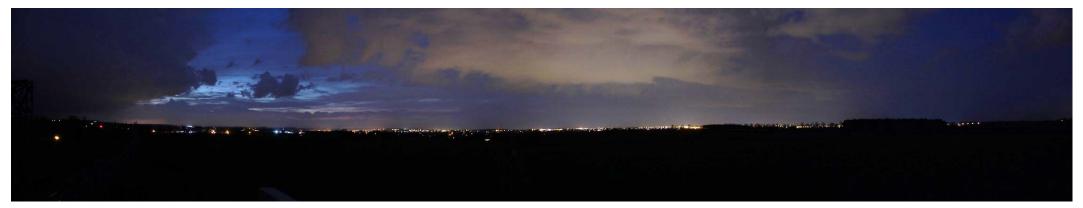
Figure 4.1 - Day and Night Time Panorama

Day time panorama 15:25pm (16-02403 – RAIL CENTRAL IMG-2016-04-12 D)

Night time panorama 21:05pm (16-02403 – RAIL CENTRAL IMG-2016-04-12 N)

View from Milton Crossing Foot Bridge of PDA 19 April 2016 GRID REF: SP 73979 53703

Figures 4.1 and 4.2 provide a daytime and night-time panoramic views of the PDA.

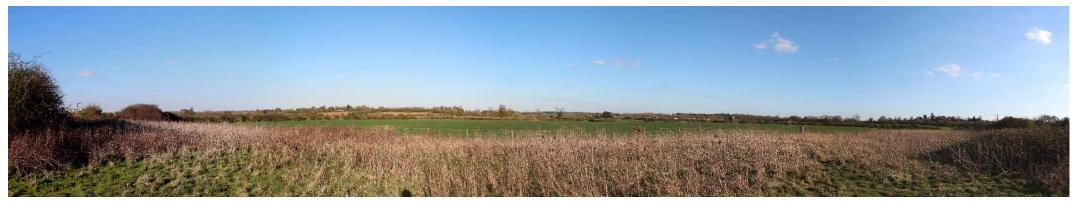
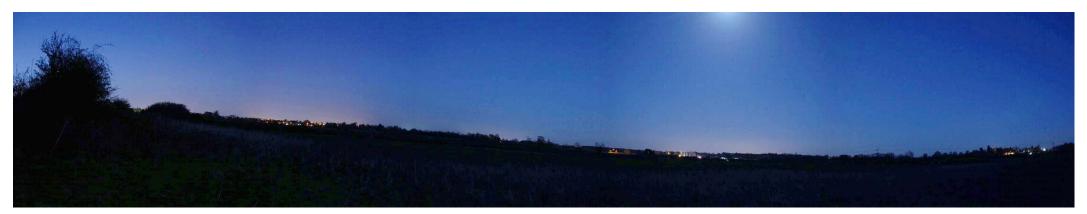
Figure 4.2 - Day and Night Time Panorama

Day time panorama 18:05pm (16-02403 - RAIL CENTRAL IMG-2016-04-19 D)

Night time panorama 21:18pm (16-02403 – RAIL CENTRAL IMG-2016-04-19 N)

View from Western aspect of PDA adjacent to A43 highway 19 April 2016 GRID REF: SP 72320 55087
