RAIL CENTRAL

APPENDIX 21.1a – Baseline Survey - J15a

APPENDIX 21.1a-DOC-1602403-20180301-Rail Central-DDM-IIP 001-PI
March 2018

The purpose of this report is to demonstrate the obtrusive light condition to survey locations in and surrounding the upgrading works to Junction 15a on the M1 to provide an understanding of the current artificial lighting condition and the pre development Environmental Zone classification.

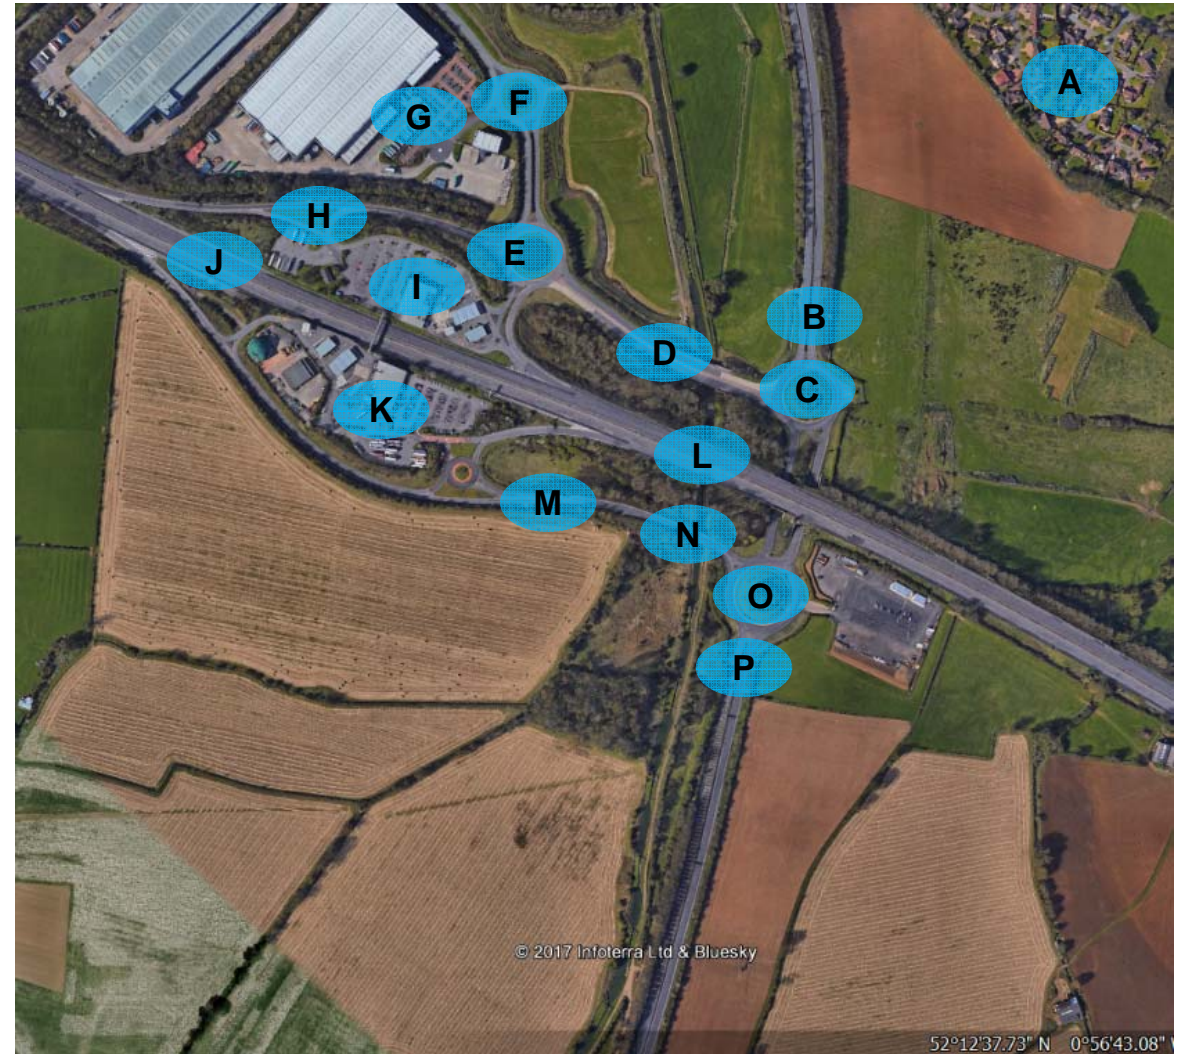
Figure I.1: Extent of Study Area (external lighting within close proximity)

- Sample locations are recorded within and adjacent to Junction 15a to provide an overview of the existing lighting conditions in order to ascertain the current Environmental Zone classifications.

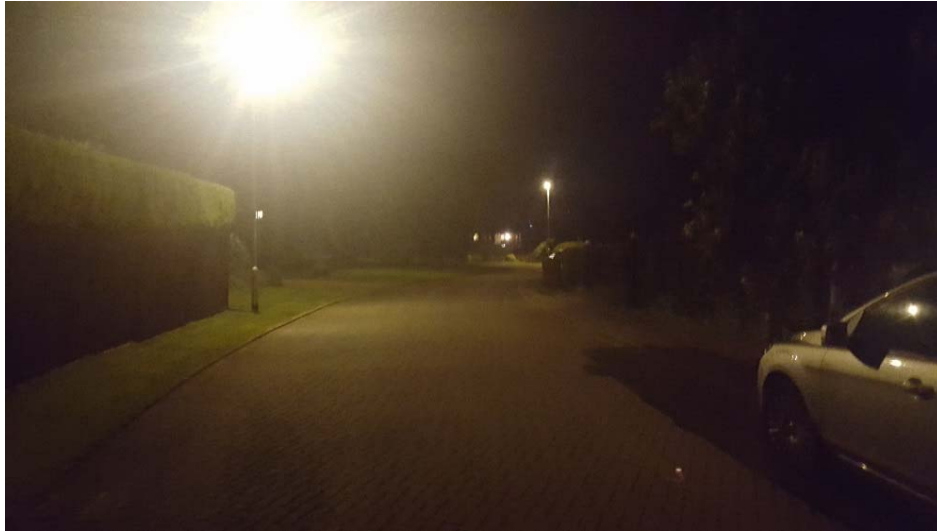
Existing Lighting A – Heronsford Road

Roadway is currently artificially lit with approximately 6m column mounted discharge lanterns to achieve an average light level of 5 Lux.

Average light levels equivalent to a S3 classification (BS 5489-1:2013)

E2: Low District Brightness

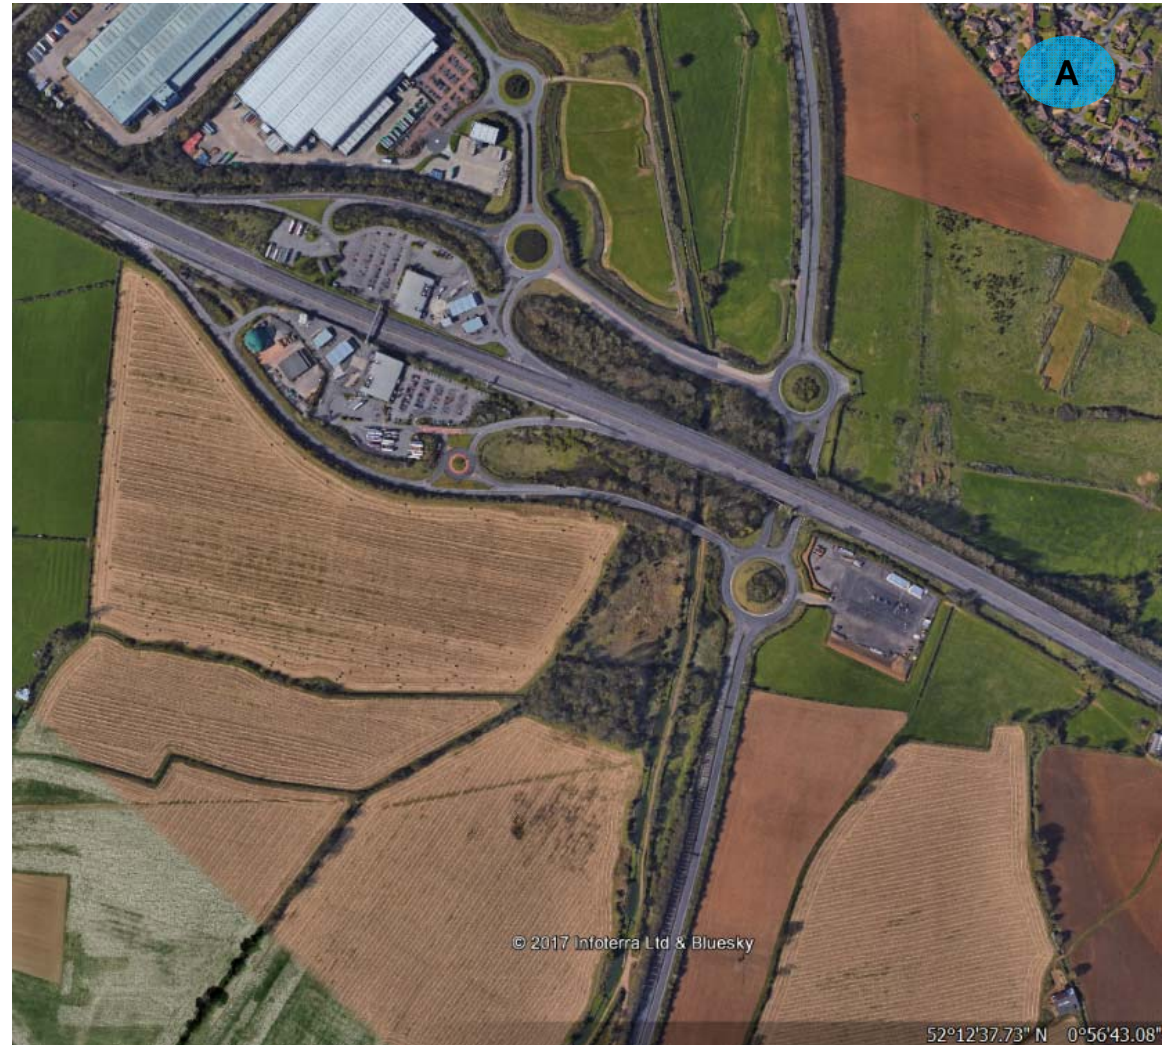
Environmental Zone Setting

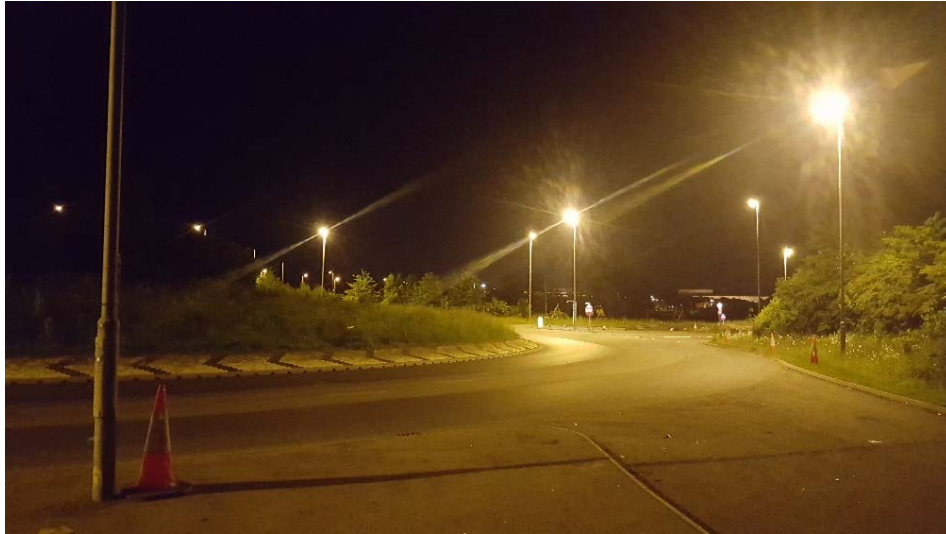
Existing Lighting B – A5123

Roadway is currently artificially lit with approximately 10/12m column mounted discharge lanterns

Average light levels judged as being equivalent to a M4 classification (BS 5489-1:2013):

0.75 cd m², U0 – 0.4, UI – 0.6

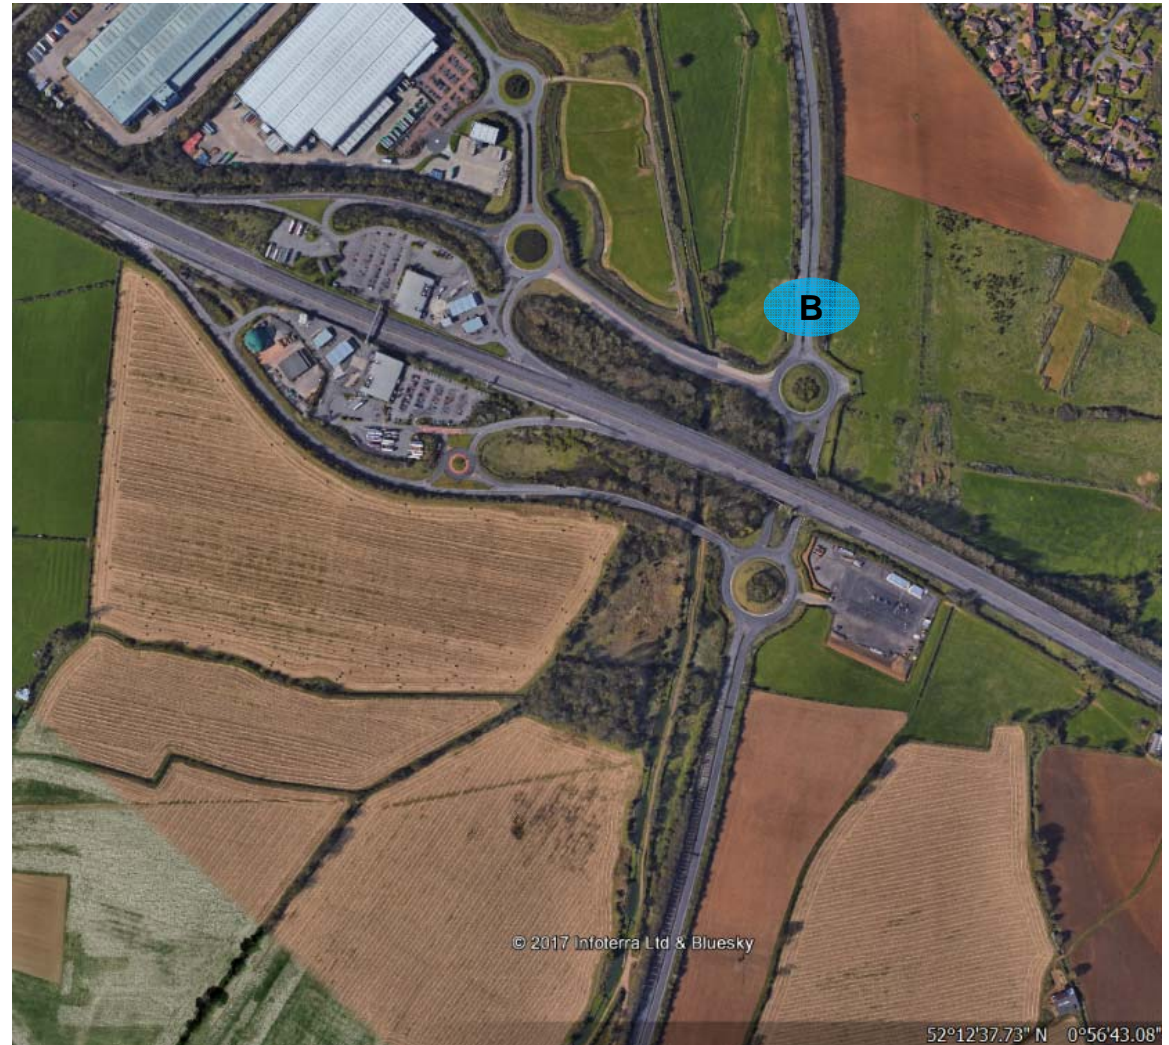
Although unsafe to access it is professionally judged that the lighting levels are representative of an:

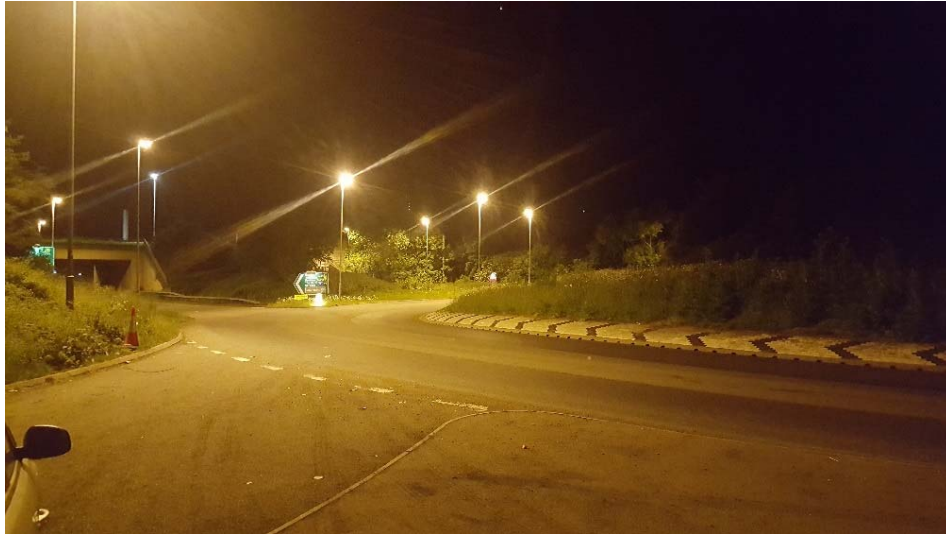
Existing Lighting C – Roundabout on A5123

Roadway is currently artificially lit with approximately 10/12m column mounted discharge lanterns

Average light levels judged as being equivalent to a CE3 lighting class (BS 5489-1:2013):

15 Lux, Uo – 0.4

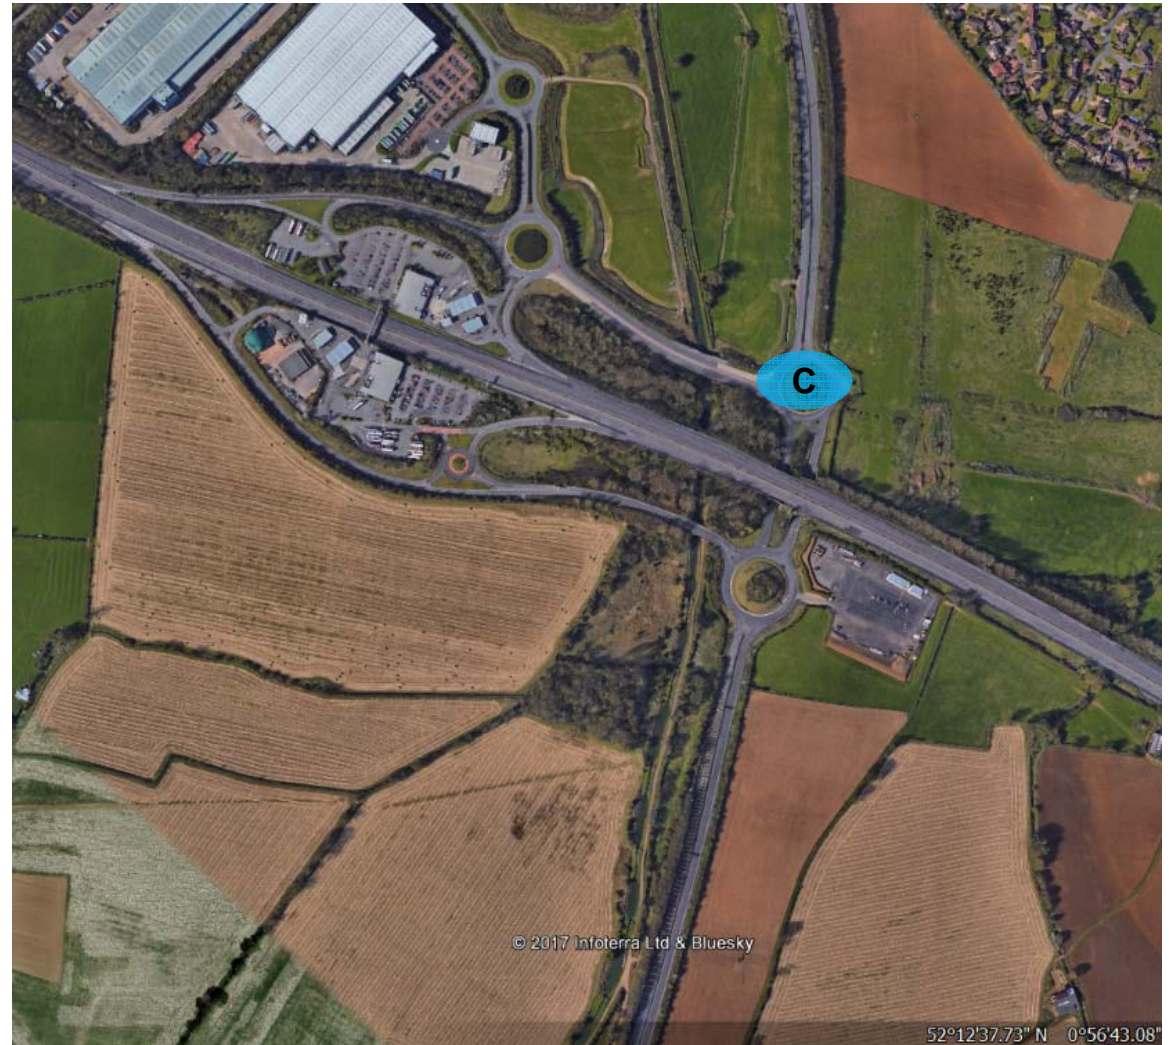
Although unsafe to access it is professionally judged that the lighting levels are representative of an:

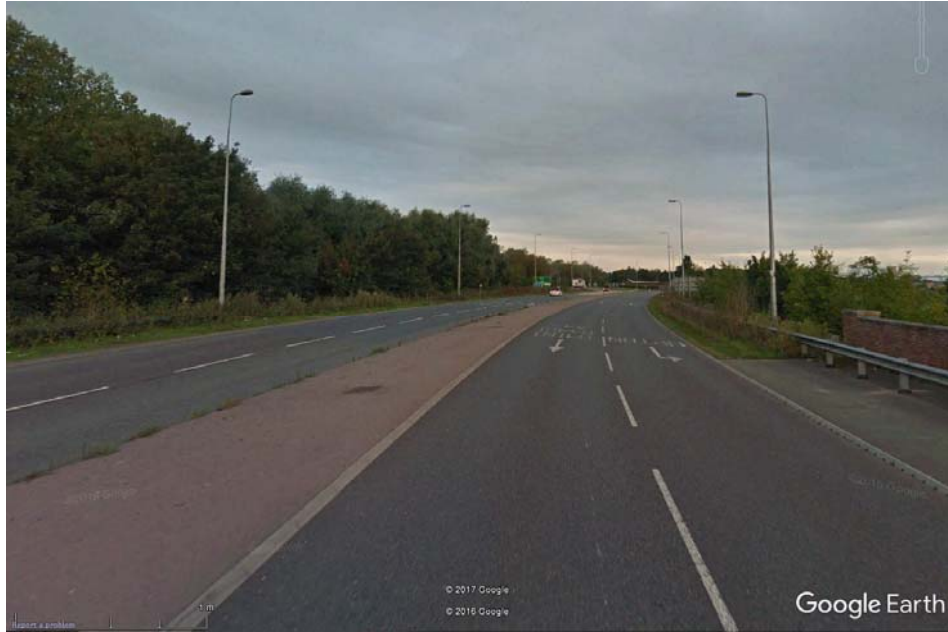
Existing Lighting D – A43

Roadway is currently artificially lit with approximately 10/12m column mounted discharge lanterns

Average light levels judged as being equivalent to a M5 classification (BS 5489-1:2013):

0.5 cd m², U0 – 0.35, UI – 0.4

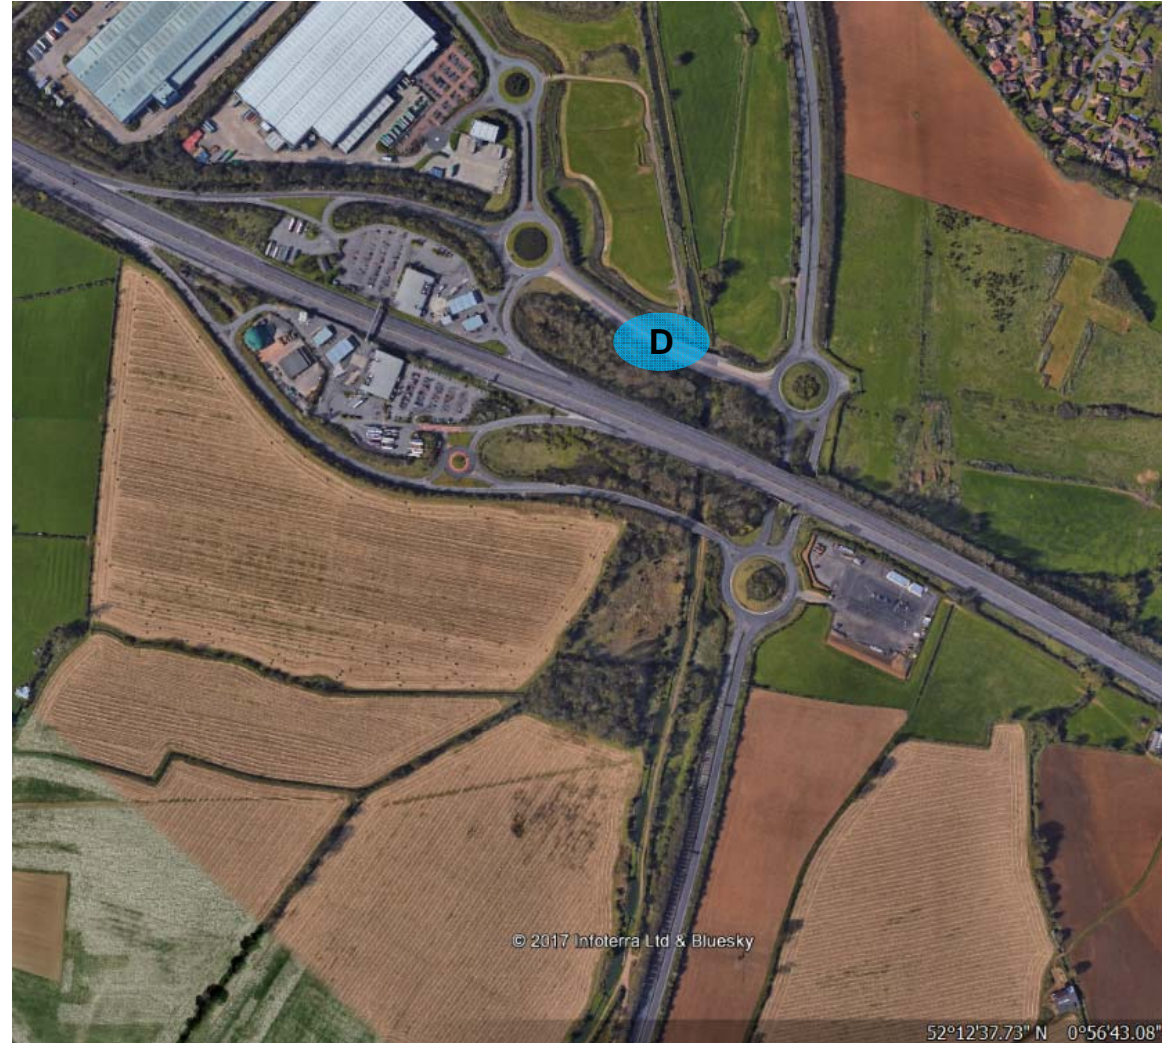
Although unsafe to access it is professionally judged that the lighting levels are representative of an:

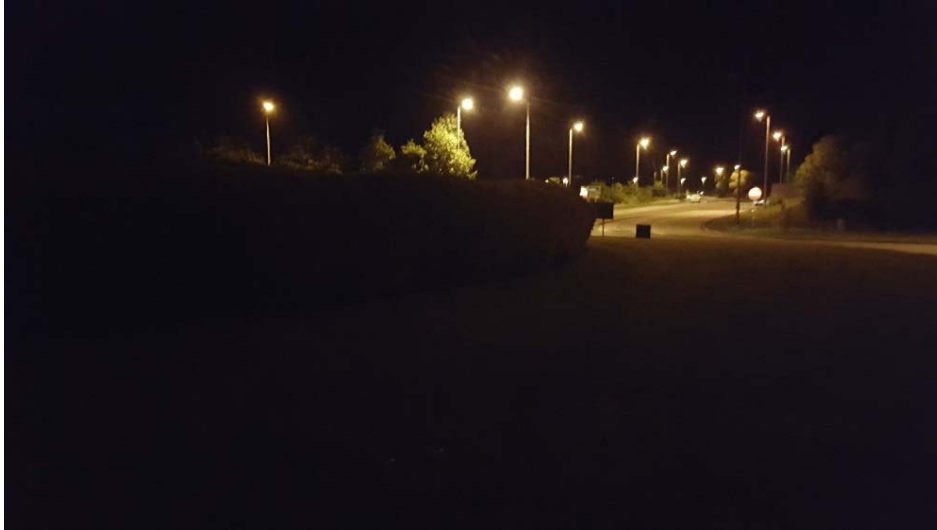
Existing Lighting E – Roundabout on A43

Roadway is currently artificially lit with approximately 10/12m column mounted discharge lanterns

Average light levels judged as being equivalent to a CE4 lighting class (BS 5489-1:2013):

10 Lux, Uo – 0.4

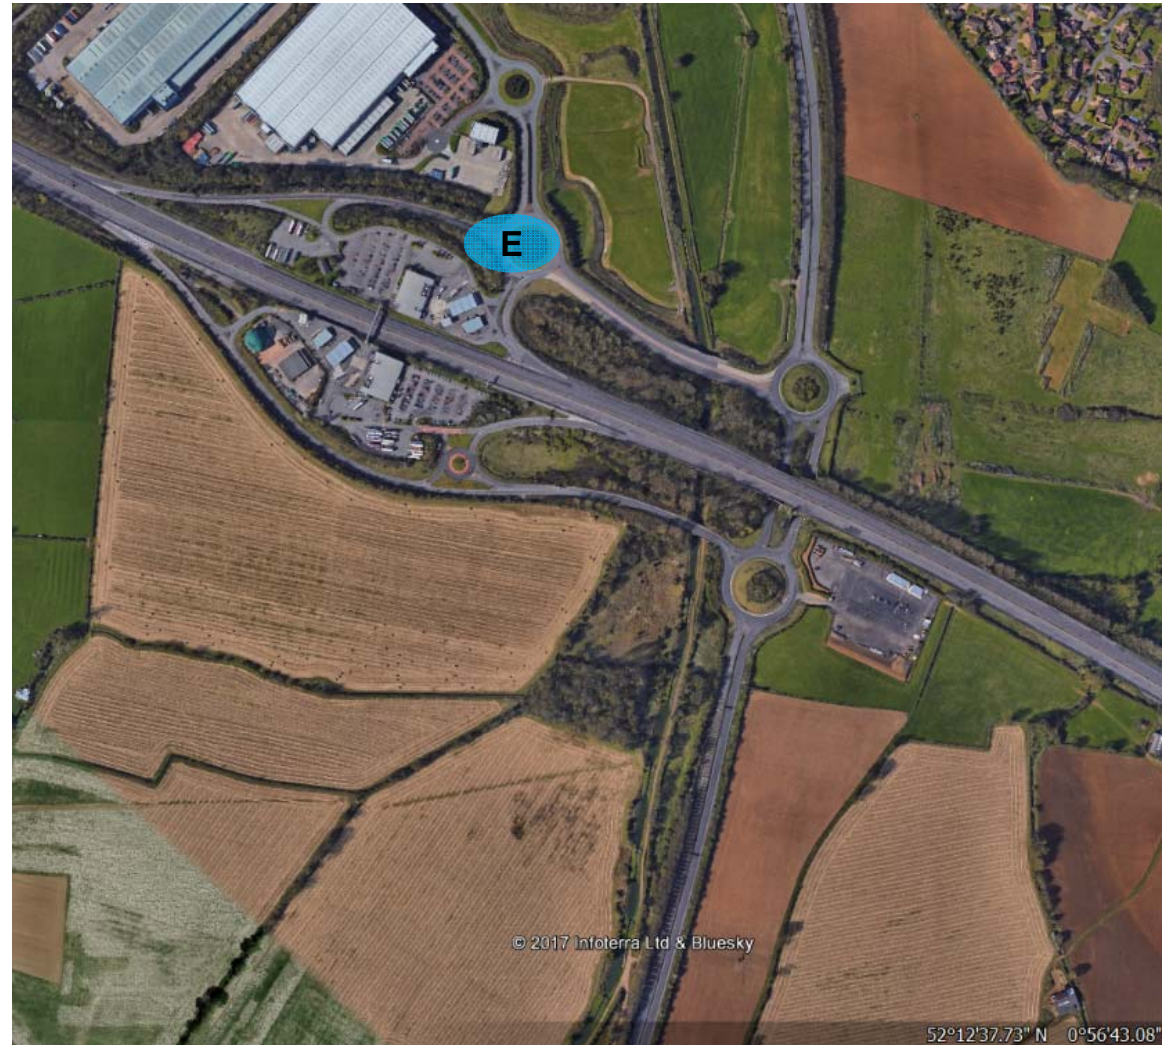
Although unsafe to access it is professionally judged that the lighting levels are representative of an:

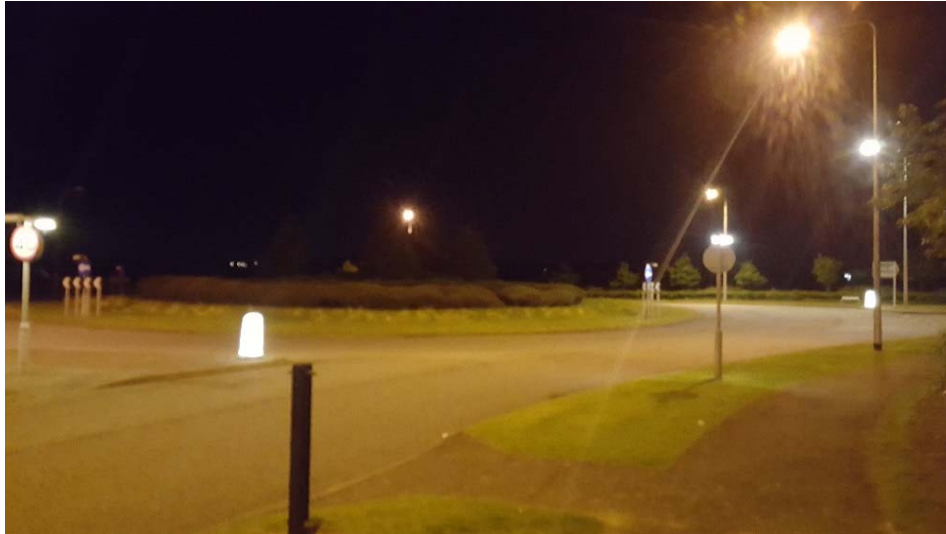
Existing Lighting F – Swan Valley Way (roundabout)

Roadway is currently artificially lit with approximately 10/12m column mounted discharge lanterns

Horizontal Lux – 12 lux

Average light levels judged as being equivalent to a CE4 lighting class (BS 5489-1:2013)

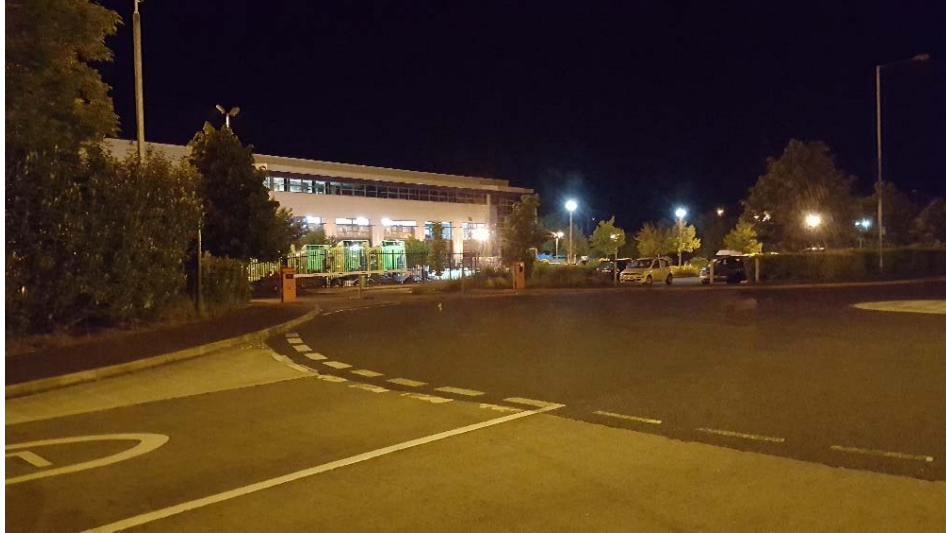
Existing Lighting G – Pets At Home - Carpark

Carpark is currently artificially lit with approximately 8/10m column mounted discharge lanterns and floodlights to achieve an average light level of 7 Lux.

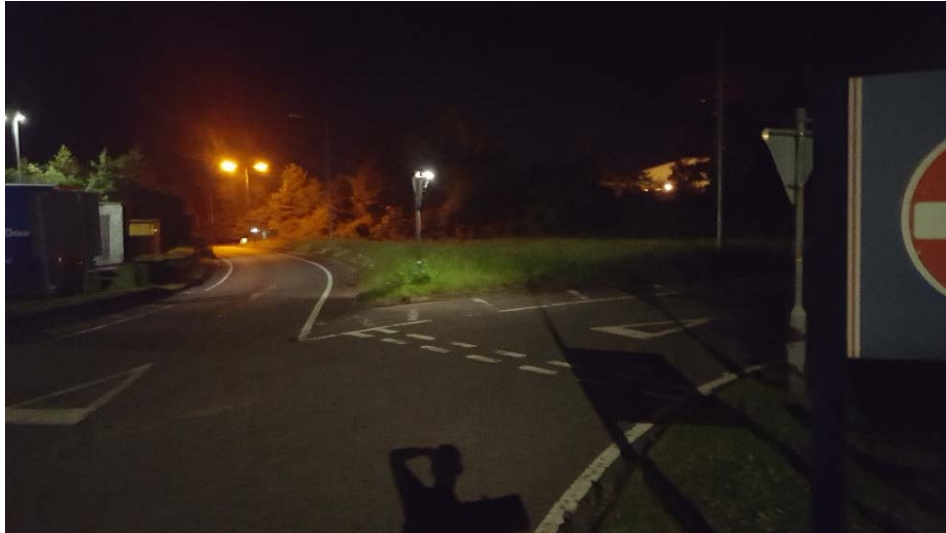
Existing Lighting H – M1 Junction 15A slip road – intersection

Roadway is currently artificially lit with approximately 10/12m column mounted discharge lanterns.

Average light levels judged as being equivalent to a M4 classification (BS 5489-1:2013):

0.75 cd m², U0 – 0.4, UI – 0.6

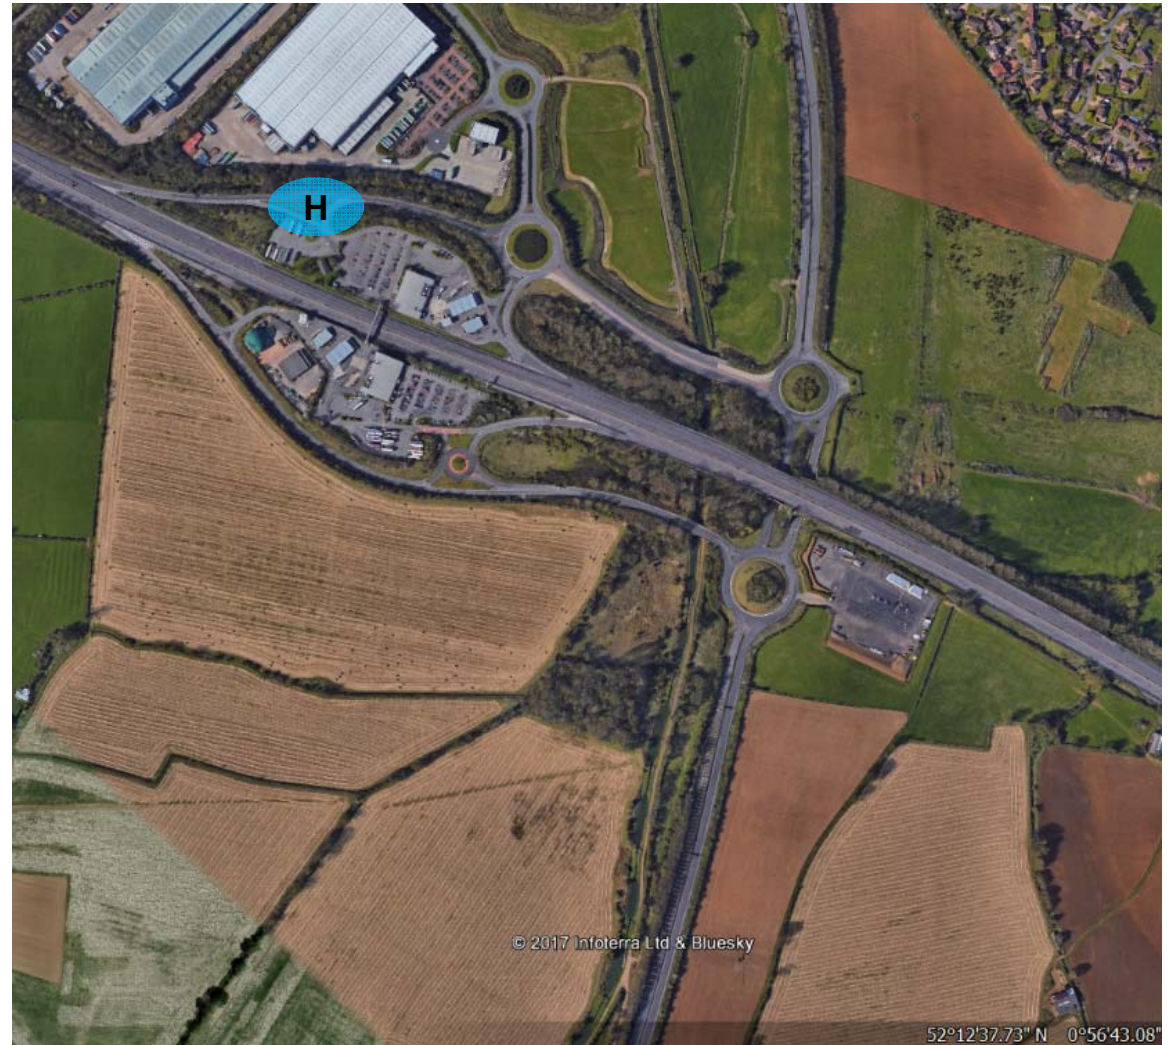
Although unsafe to access it is professionally judged that the lighting levels are representative of an:

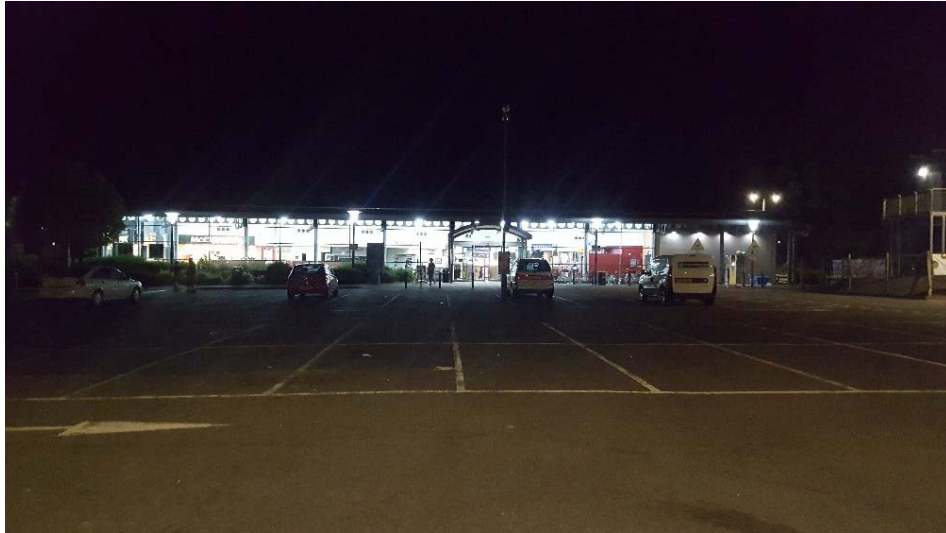
Existing Lighting I – M1 Junction 15A Services (NORTH)

Parking and service areas are currently artificially lit with approximately 8/10m column mounted discharge lanterns to achieve an average light level of 17 Lux.

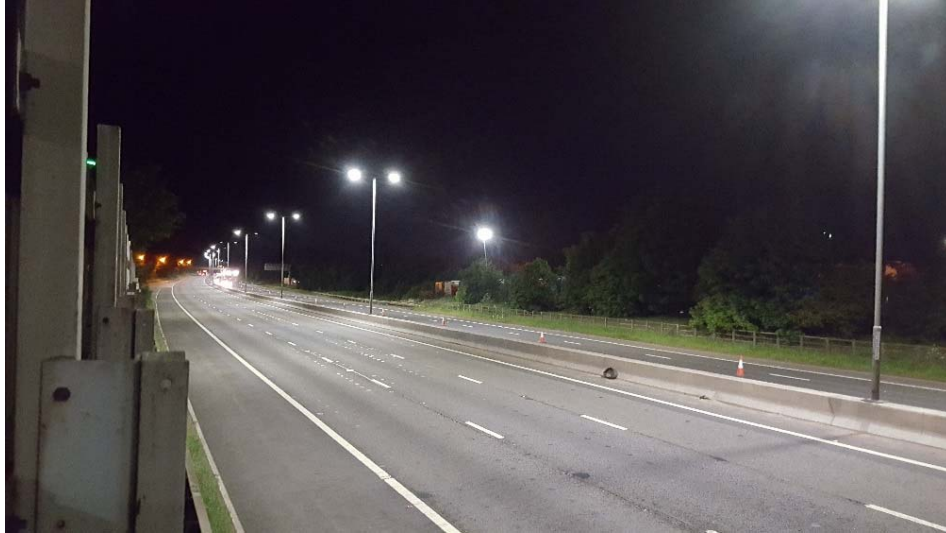
Existing Lighting J – M1 North

Roadway is currently artificially lit with approximately 12m column mounted discharge lanterns

Average light levels judged as being equivalent to a M2 classification (BS 5489-1:2013):

1.5 cd m², U0 – 0.4, U1 – 0.7

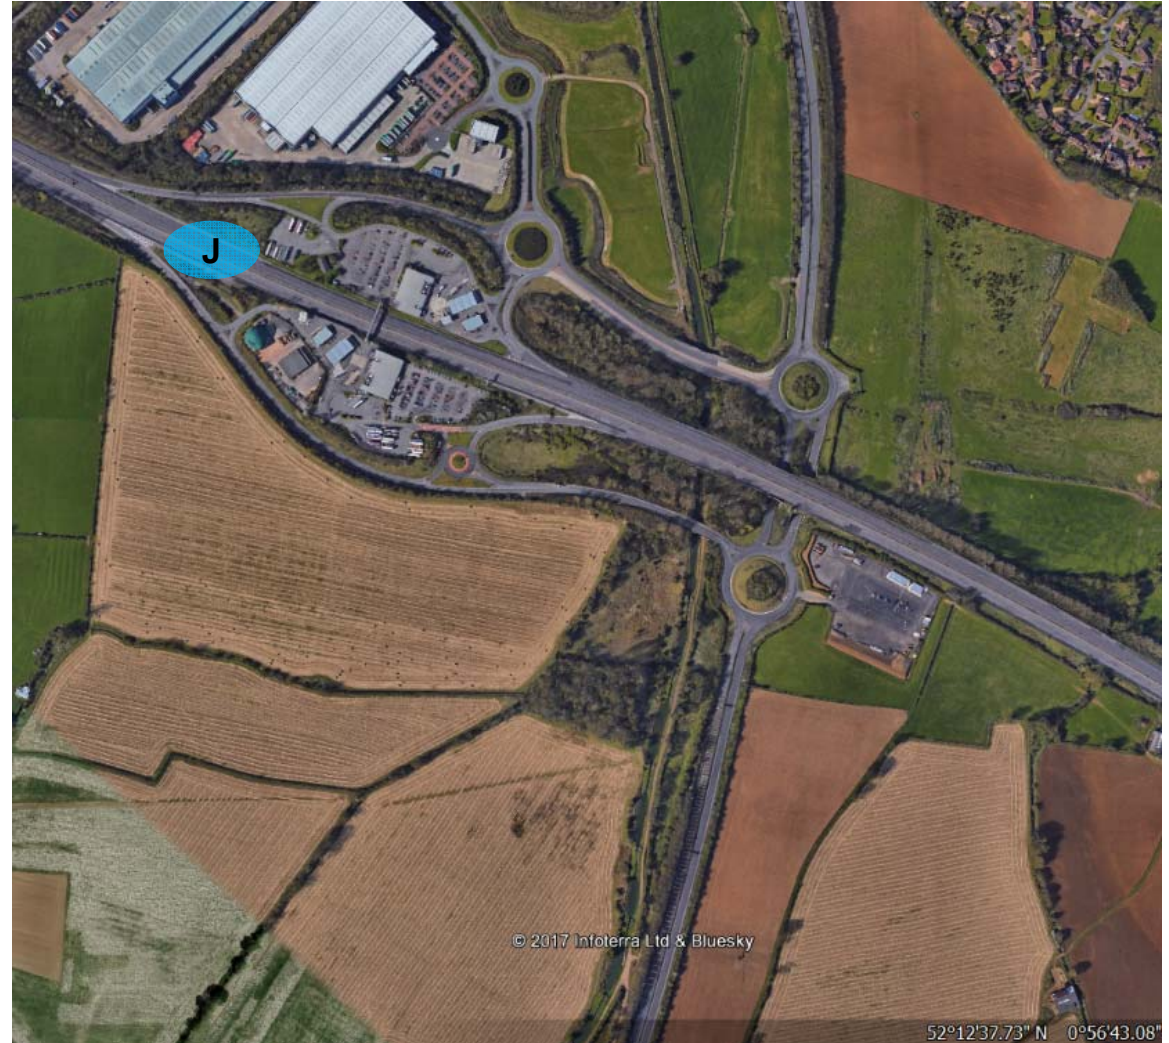
Although unsafe to access it is professionally judged that the lighting levels are representative of an:

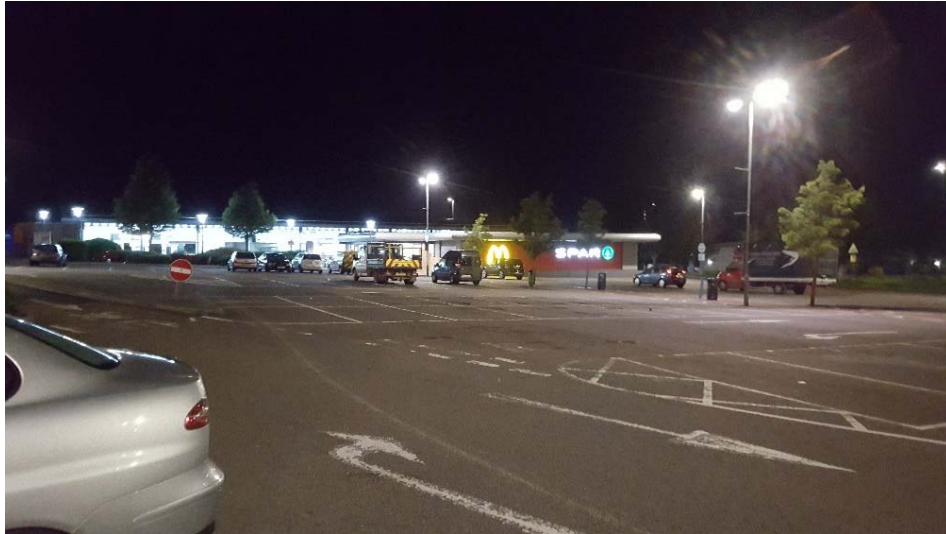
Existing Lighting K – M1 Junction 15A Services (SOUTH)

Parking and service areas are currently artificially lit with approximately 8/10m column mounted discharge lanterns to achieve an average light level of 8 Lux.

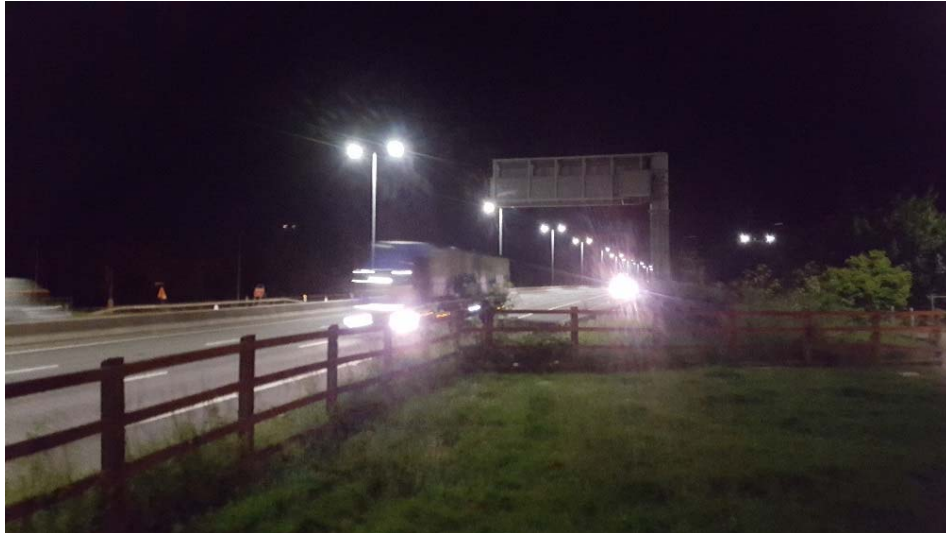
Existing Lighting L – M1 South

Roadway is currently artificially lit with approximately 12m column mounted discharge lanterns

Average light levels judged as being equivalent to a M2 classification (BS 5489-1:2013):

1.5 cd m², U0 – 0.4, UI – 0.7

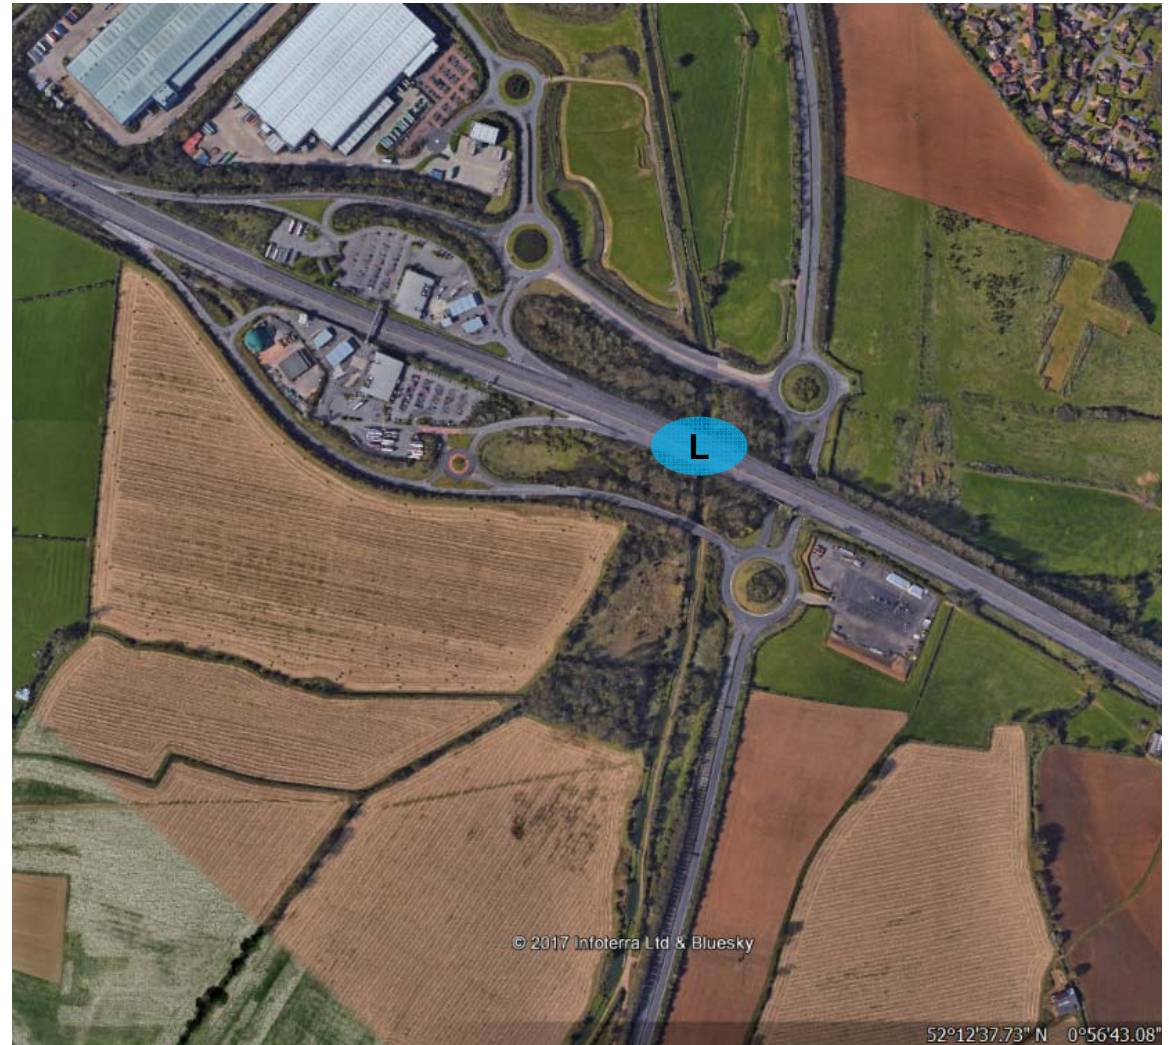
Although unsafe to access it is professionally judged that the lighting levels are representative of an:

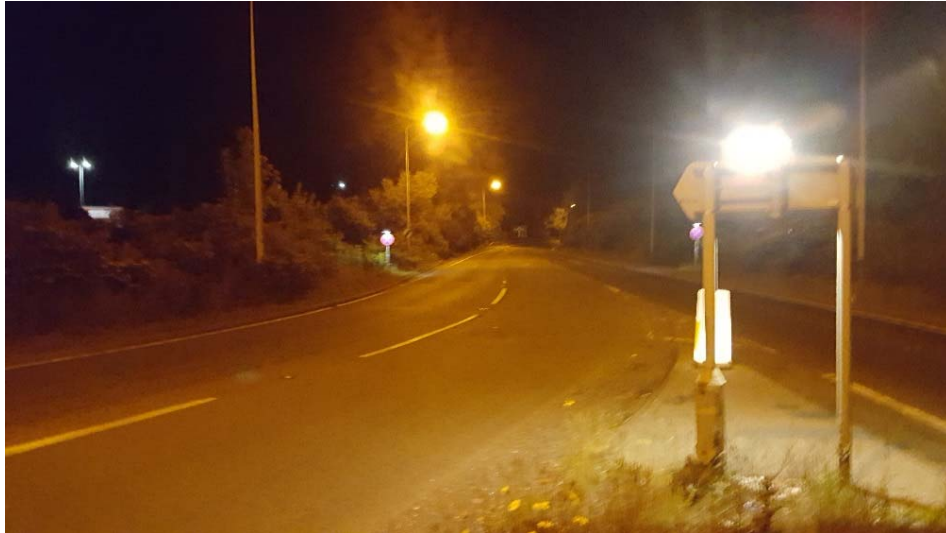
Existing Lighting M – A43

Roadway is currently artificially lit with approximately 10/12m column mounted discharge lanterns

Average light levels judged as being equivalent to a M5 classification (BS 5489-1:2013):

0.5 cd m², U0 – 0.35, UI – 0.4

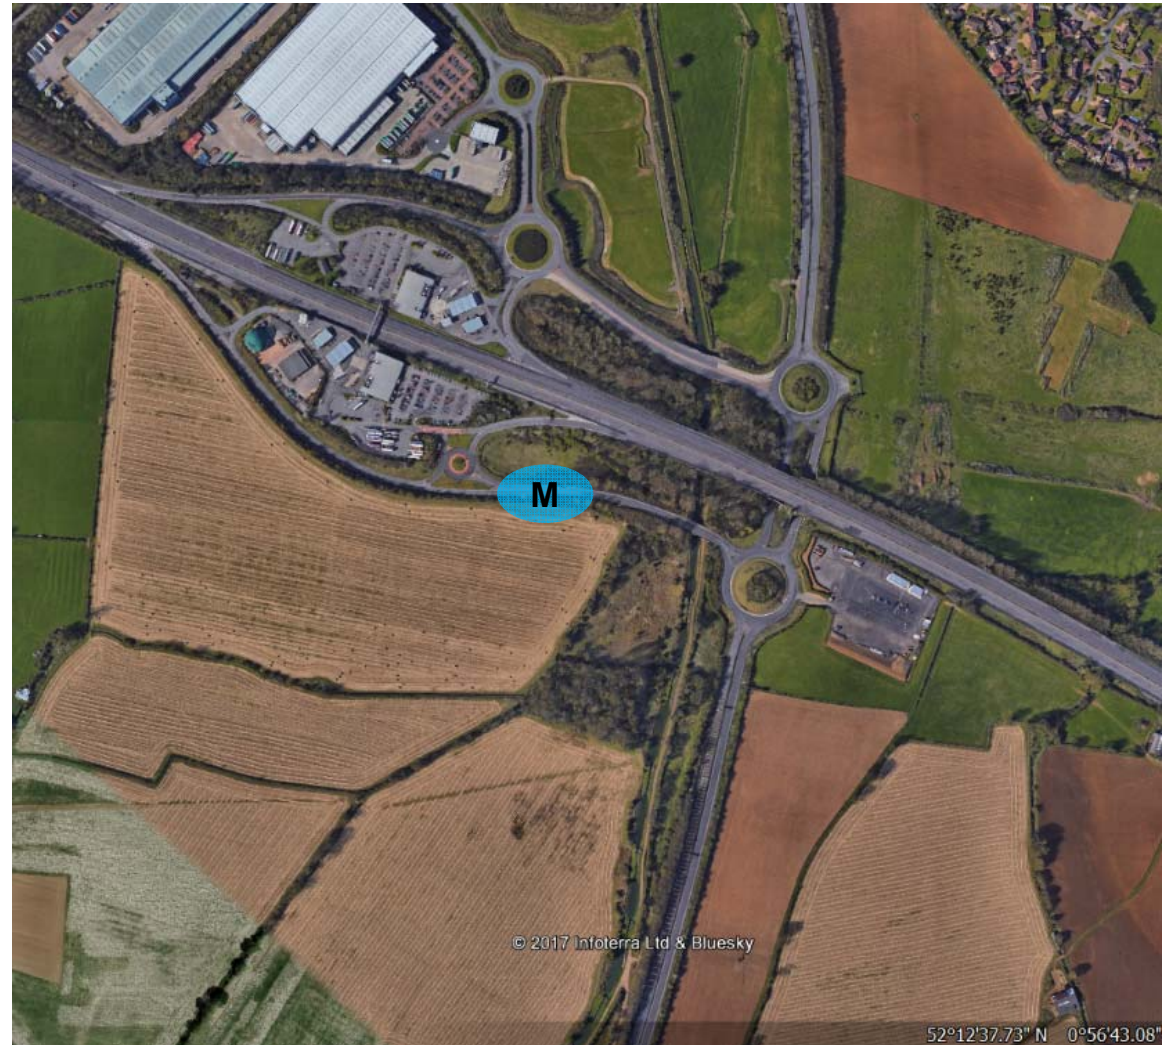
Although unsafe to access it is professionally judged that the lighting levels are representative of an:

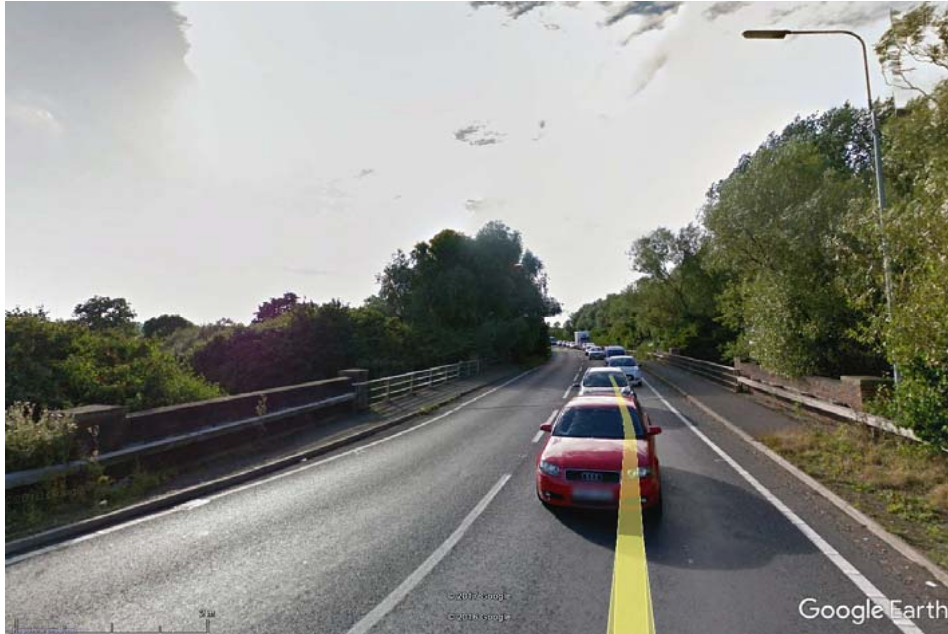
Existing Lighting N – A43

Average light levels judged as being equivalent to a M3 classification (BS 5489-1:2013):

1.0 cd m², U0 – 0.4, UI – 0.6

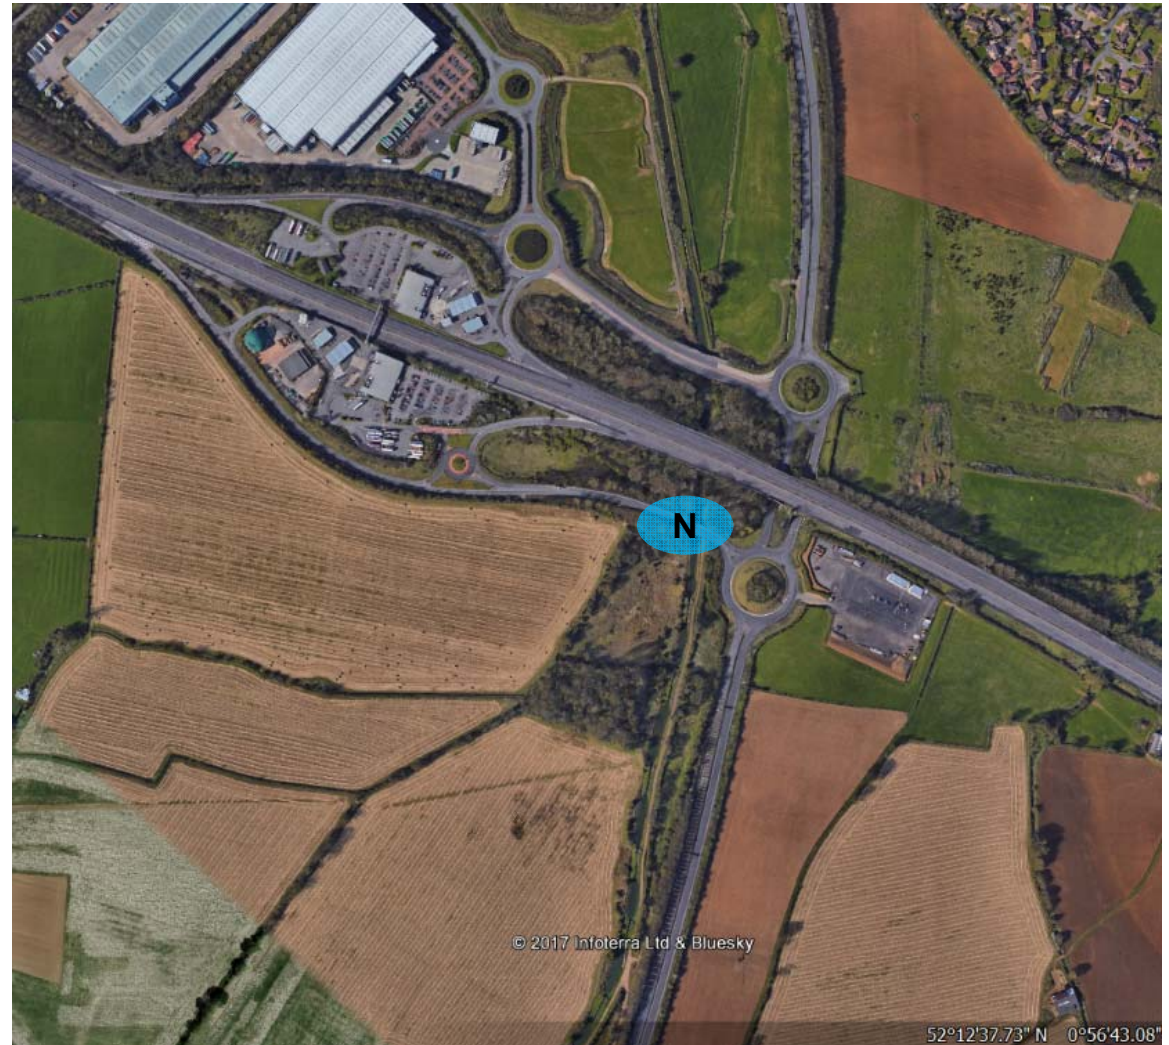
Although unsafe to access it is professionally judged that the lighting levels are representative of an:

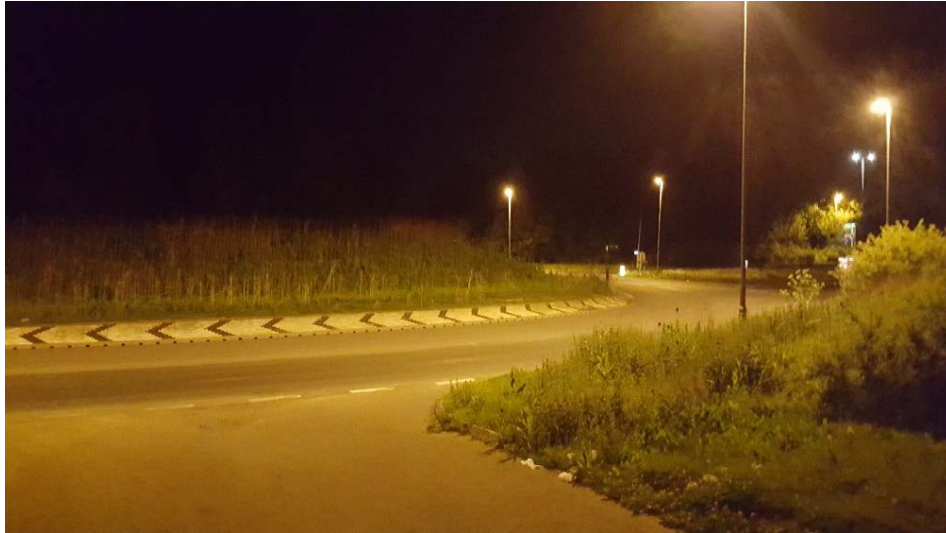
Existing Lighting O – A43 Roundabout

Roadway is currently artificially lit with approximately 10/12m column mounted discharge lanterns

Average light levels judged as being equivalent to a CE3 lighting class (BS 5489-1:2013):

15 Lux, Uo – 0.4
