RAIL CENTRAL

APPENDIX 21.1a – Baseline Survey - J15a

APPENDIX 21.1a-DOC-1602403-20180301-Rail Central-DDM-IIP 001-PI
March 2018

The purpose of this report is to demonstrate the obtrusive light condition to survey locations in and surrounding the upgrading works to Junction 15a on the M1 to provide an understanding of the current artificial lighting condition and the pre development Environmental Zone classification.

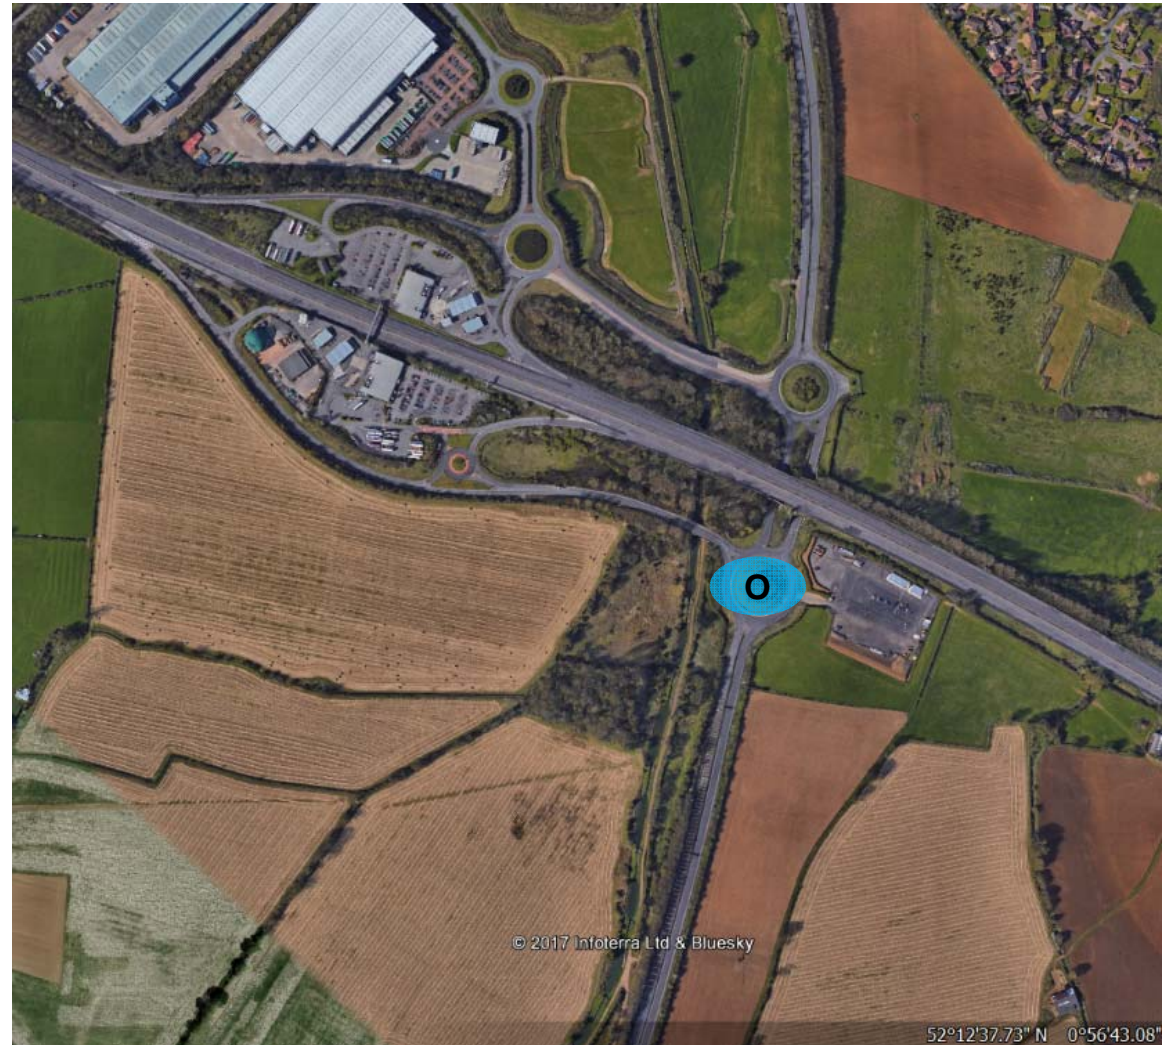
Existing Lighting O – A43 Roundabout

Roadway is currently artificially lit with approximately 10/12m column mounted discharge lanterns

Although unsafe to access it is professionally judged that the lighting levels are representative of an:

Average light levels judged as being equivalent to a CE3 lighting class (BS 5489-1:2013):

15 Lux, Uo – 0.4

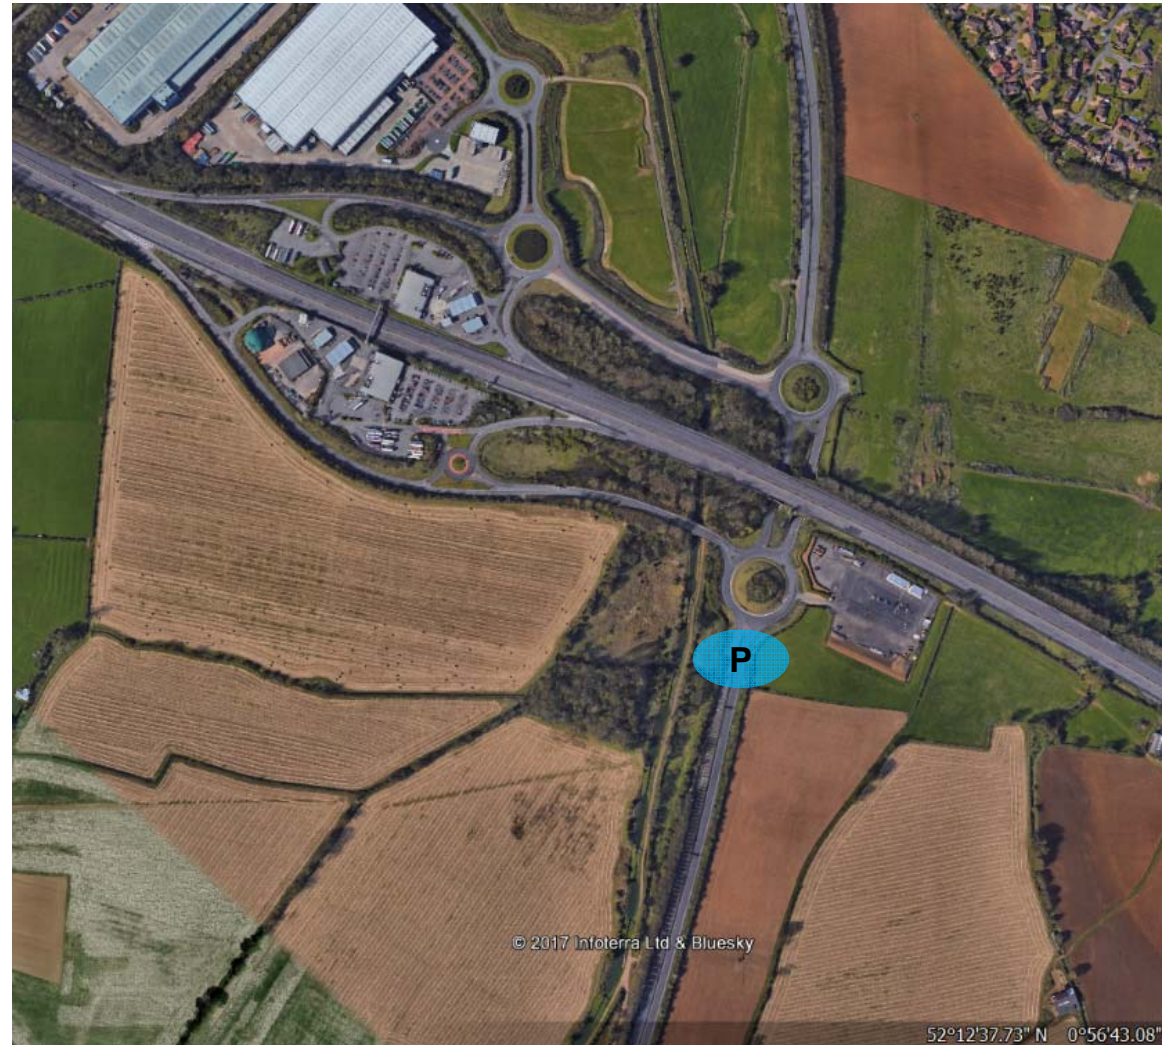
Existing Lighting P – A34

Although unsafe to access it is professionally judged that the lighting levels are representative of an:

Average light levels judged as being equivalent to a M4 classification (BS 5489-1:2013):

0.75 cd m², U0 – 0.4, UI – 0.6

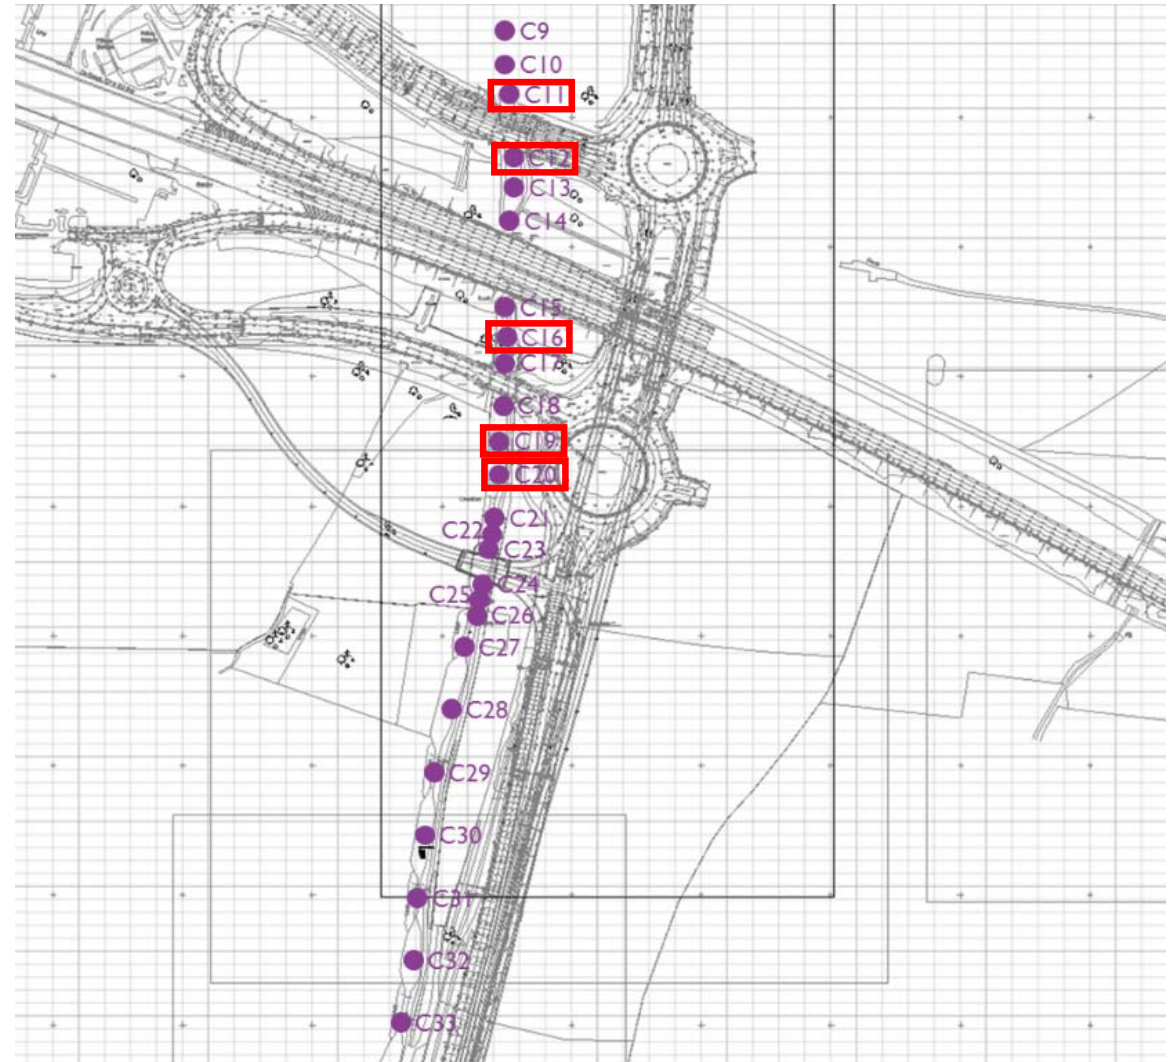
Ecological and Waterbody Constraints

Natural screening provided by existing tree lines and hedgerows.

The notable increase above natural moonlight conditions occurs at survey points C11 and C12 where light spill from the northern A43 bridge increases light conditions to the canal and towpath to 5.98 Lux.

A minor increase is also notable at survey point C16 where light spill from the M1 and southern A43 bridge and roundabout increases light conditions to the canal and towpath to 0.56 Lux.

A minor increase is also notable at survey points C19 and C20 where light spill from the southern A43 bridge and roundabout increases light conditions to the canal and towpath to 0.45 Lux.

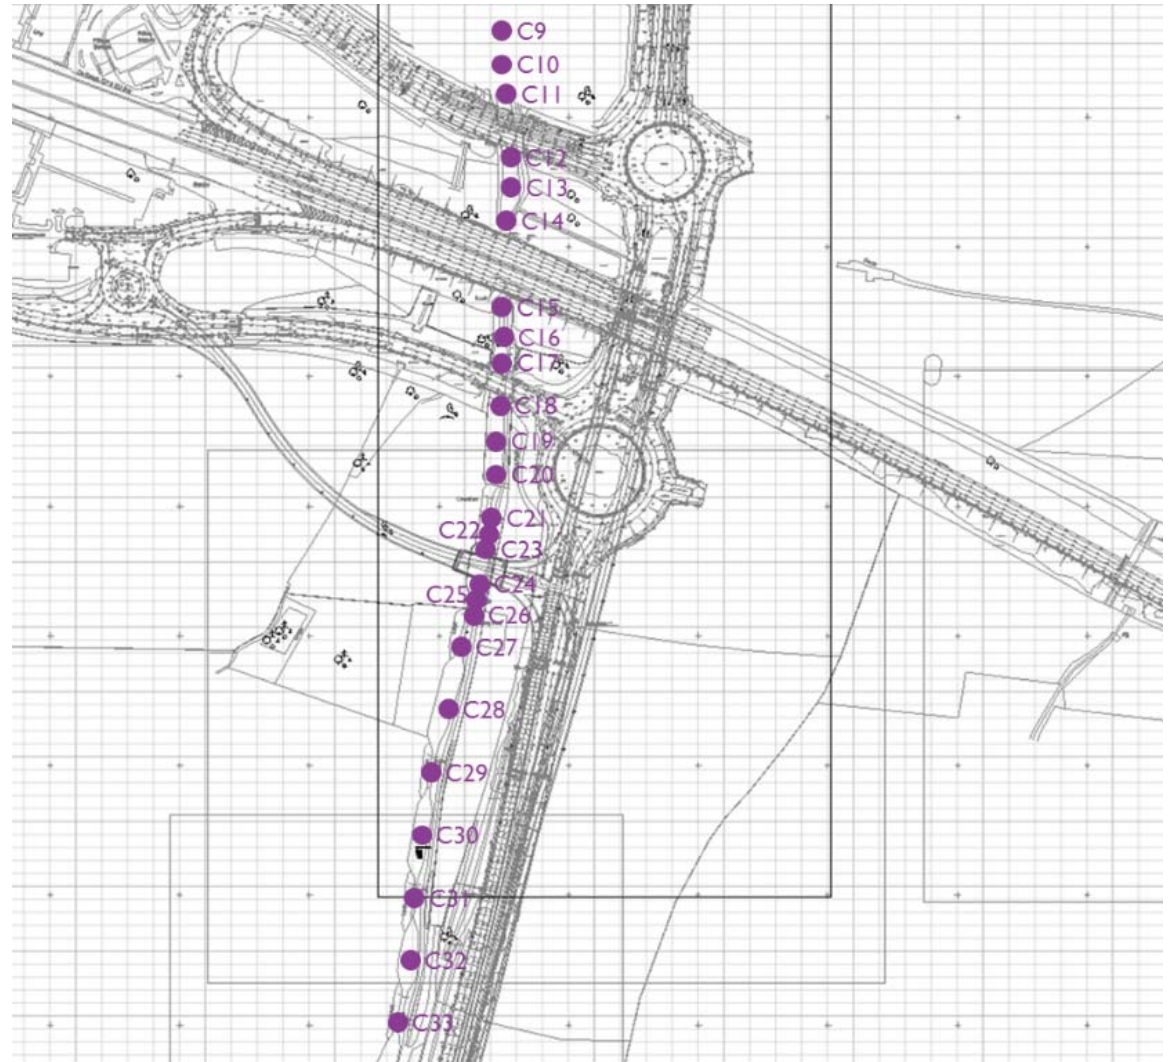
Grand Union Canal / Northampton Arm (tow path) - Ecology Constraints

Survey Location	Peak Illuminance Measurement (Lux) Vertical @ 1.5m + AFL	Peak Illuminance Measurement (Lux) Horizontal @ Ground level
C9	0.10	0.02
C10	0.17	0.06
C11	2.63	3.14
C12	4.85	5.98
C13	0.19	0.03
C14	0.09	0.02
C15	0.03	0.03
C16	0.56	0.29
C17	0.03	0.02
C18	0.12	0.07
C19	0.45	0.02
C20	0.25	0.08
C21	0.03	0.01
C22	0.03	0
C23	0.03	0.01
C24	0.04	0.02
C25	0.04	0.02
C26	0.04	0.02
C27	0.02	0.01
C28	0.02	0.02
C29	0.02	0.01
C30	0.02	0.01
C31	0.02	0.01
C32	0.02	0.01

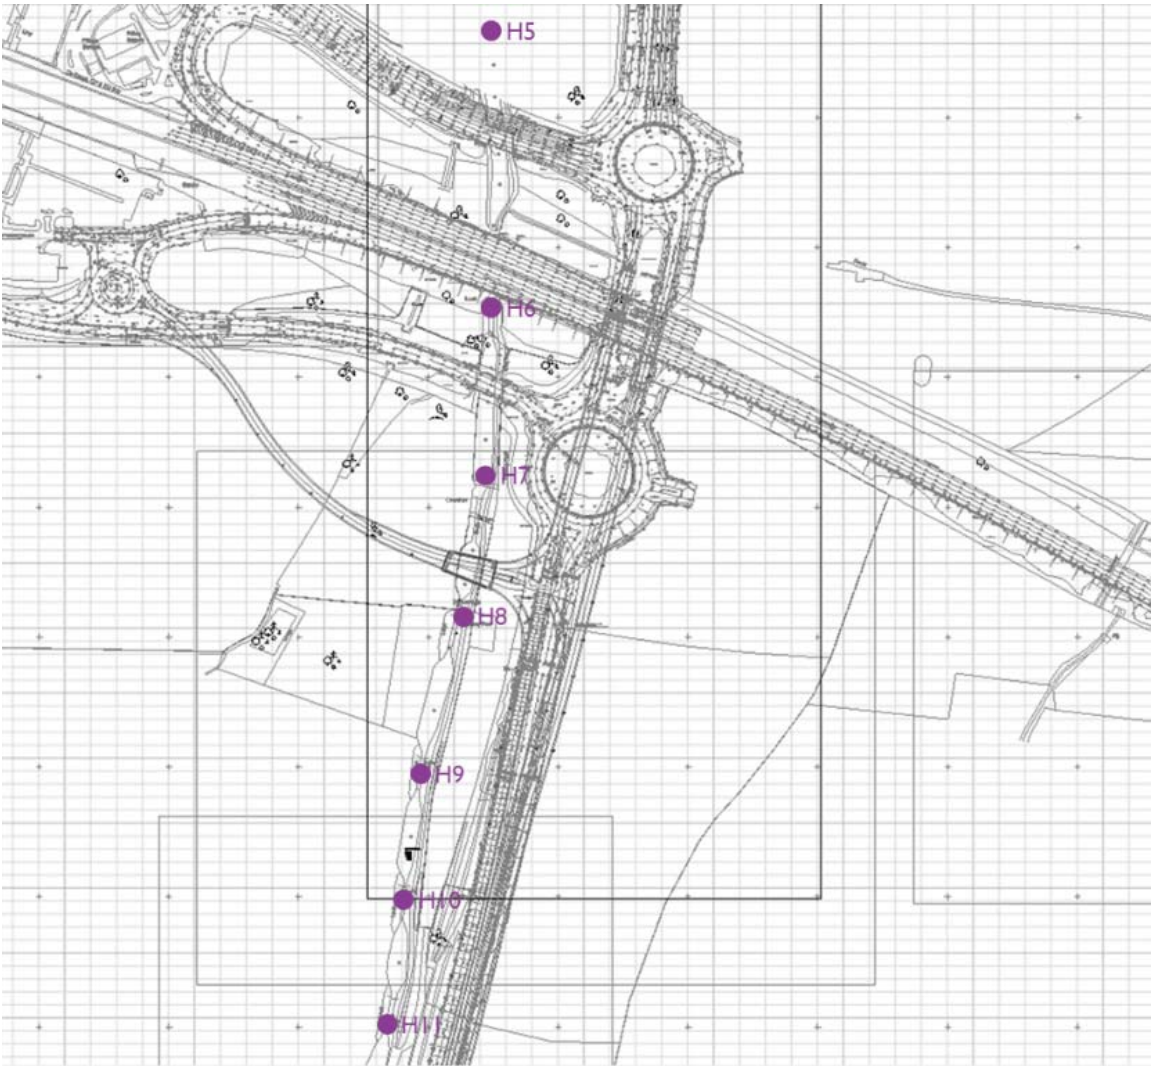
Heritage Constraints

Natural screening provided by existing tree lines and hedgerows.

A minor increase is also notable at survey points H7 where light spill from the A43 roundabout increases light conditions to the canal and towpath to 0.25 Lux.
