Rail Central Strategic Rail Freight Interchange

Site Waste Management Plan

Hydrock Ref. RCL-HYD-XX_REM-RP-GE-3002-S2-
P4

February 2018

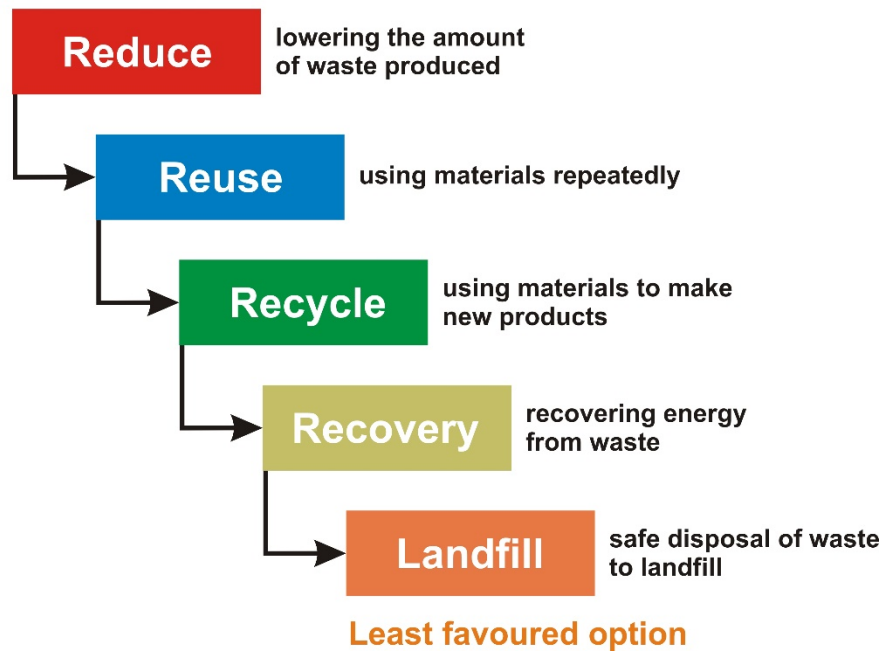
The appointed Principal Contractor will maximise the re-use of materials, on-site, wherever practicable. Works will follow the waste hierarchy as detailed below.
